# TOWN OF THREE HILLS

## REQUEST FOR PROPOSAL FOR Centennial Place Arena – Roof Repairs

# ROOF EXPERTISE REPORT

Name	Address	
Centennial Place Arena	202, 3 Avenue North Three Hills AB T0M 2A0	
Number of roof areas	Number of drains	Total surface
5	15	39,573 pi²
Elevation from ground to roof edge		
General information

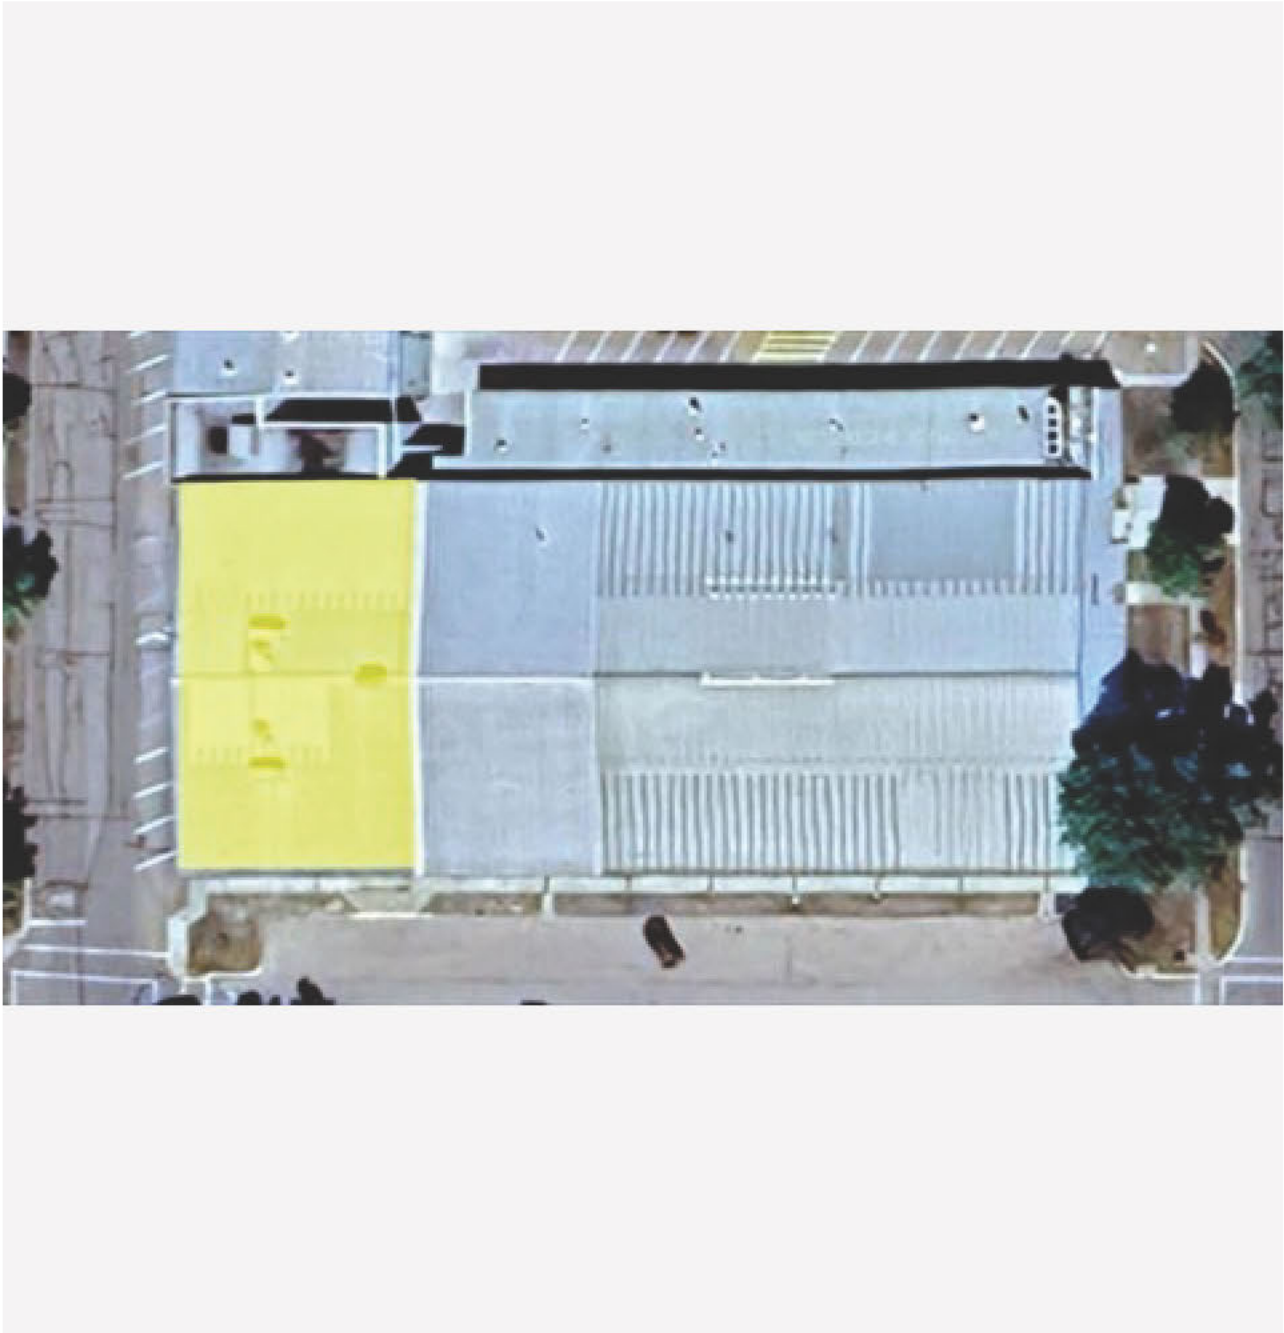
Number of drains	2	Type / système drainage	Gutter
Roofing system	Conventional	Decking / structure	Steel
Insulation panel	Batt insulation	Insulation location	Attic
Membrane composition / Overlay	Metallic	Type de membrane flashing	Liquid, elastomeric finishing membrane
Type of steel flashing	Painted steel

Name	Surface area	Rating	Condition	Life expectancy
<div><div></div>A</div>	9,471 pi²	Fair	51-60%	5 to 10 years

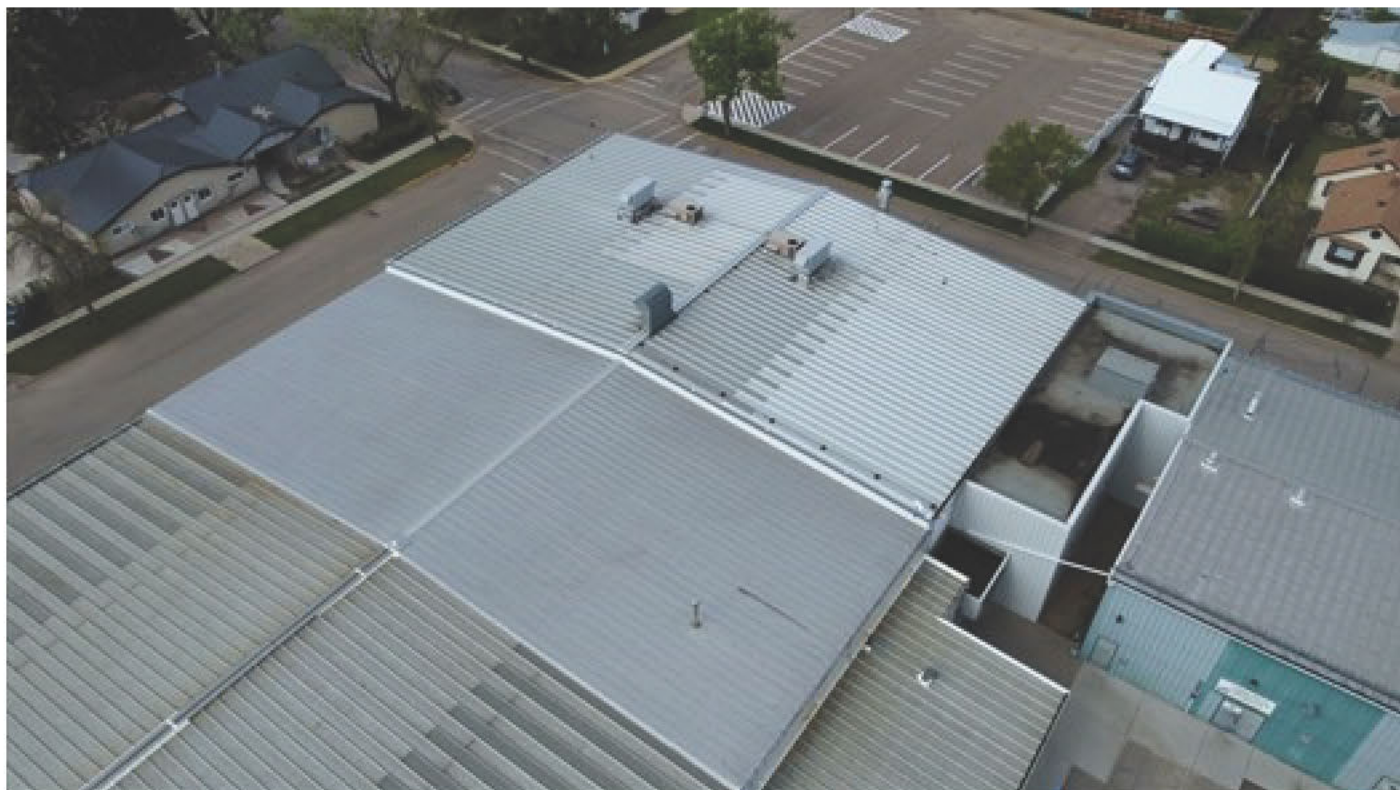
**A.1**

Overview showing roof area A in generally fair condition.

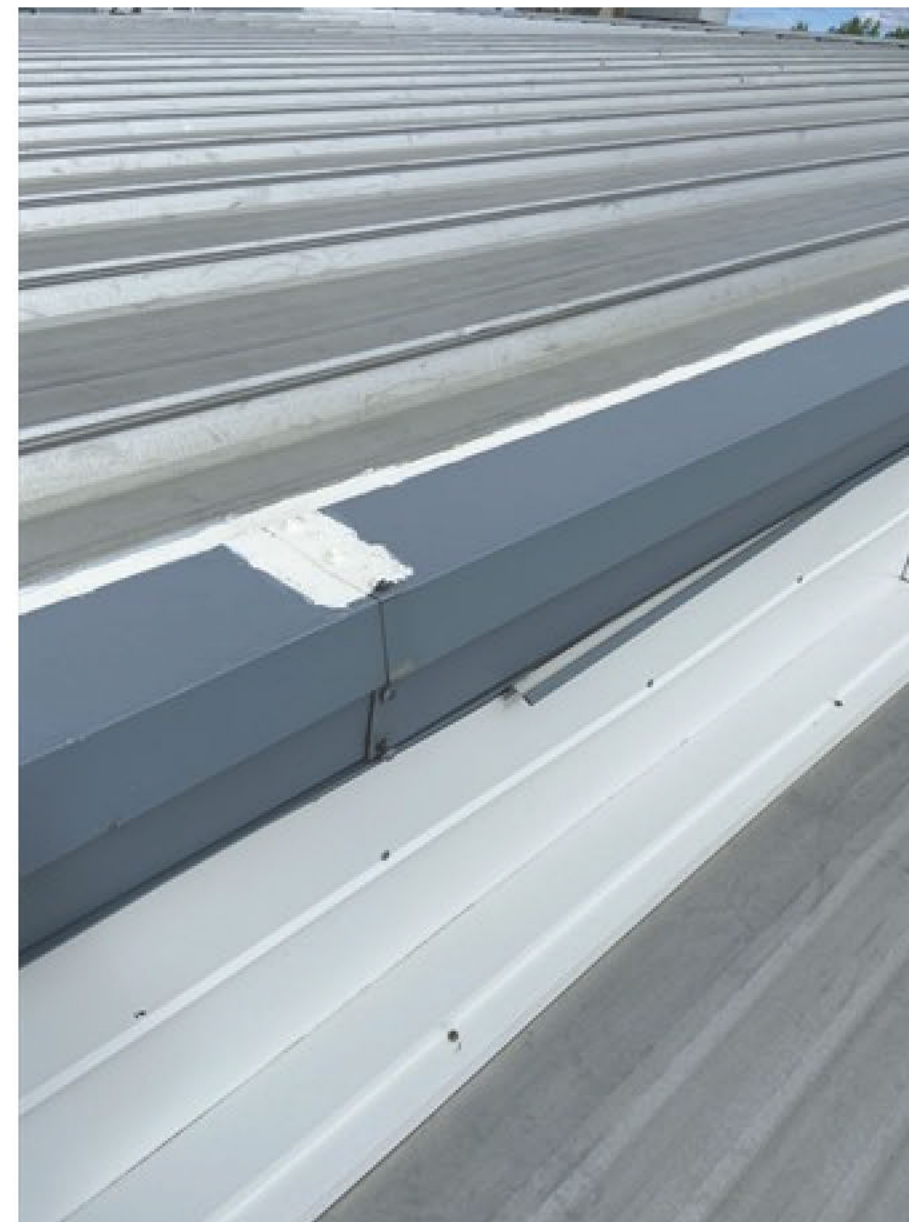
**A.2**

Existing panels in overall fair condition and remain well secured in place. Inadequately secured metal perimeter flashings were observed along the roof divider.

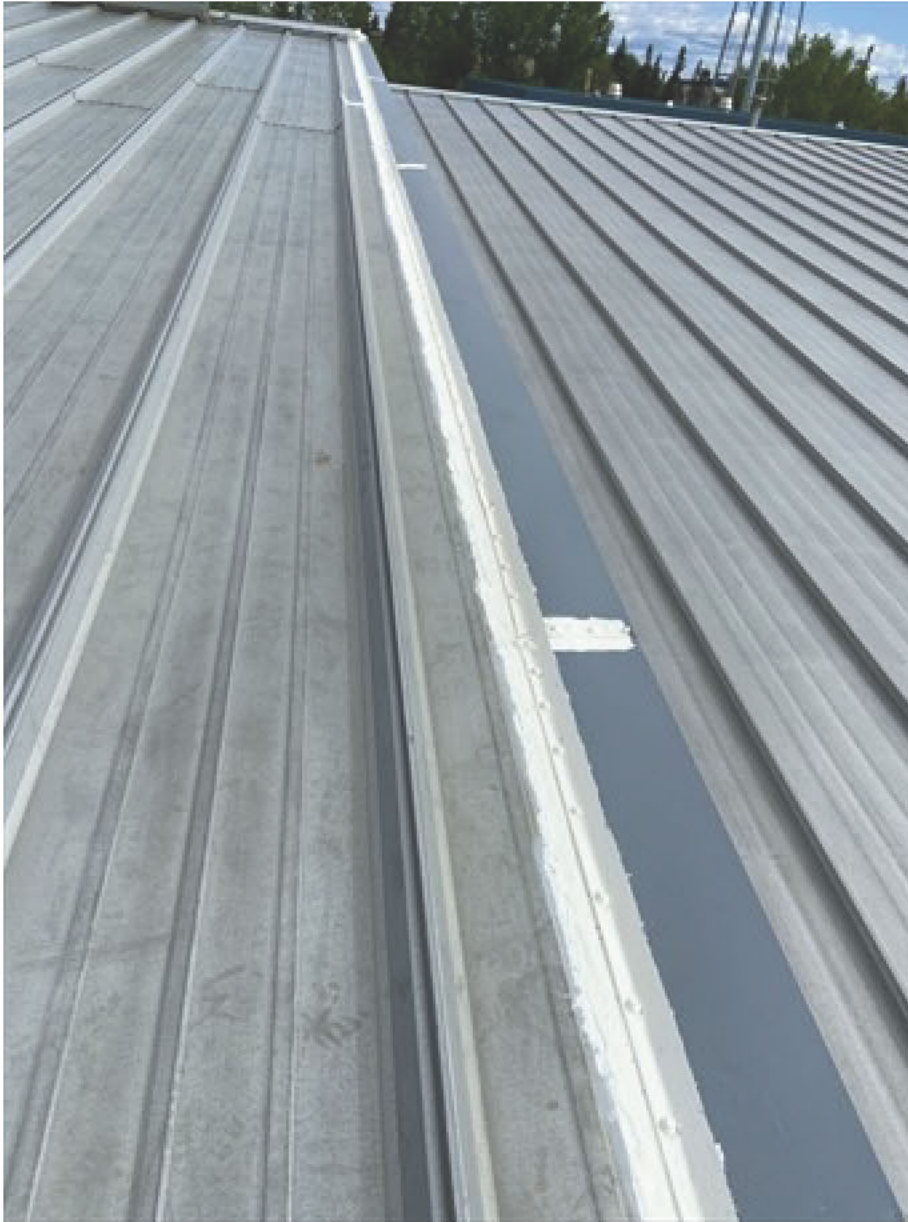
**A.3**

This view shows previously completed repairs along the roof divider using elastomeric coating. Reoccurring water ingress was reported along the divider at the time of the review.

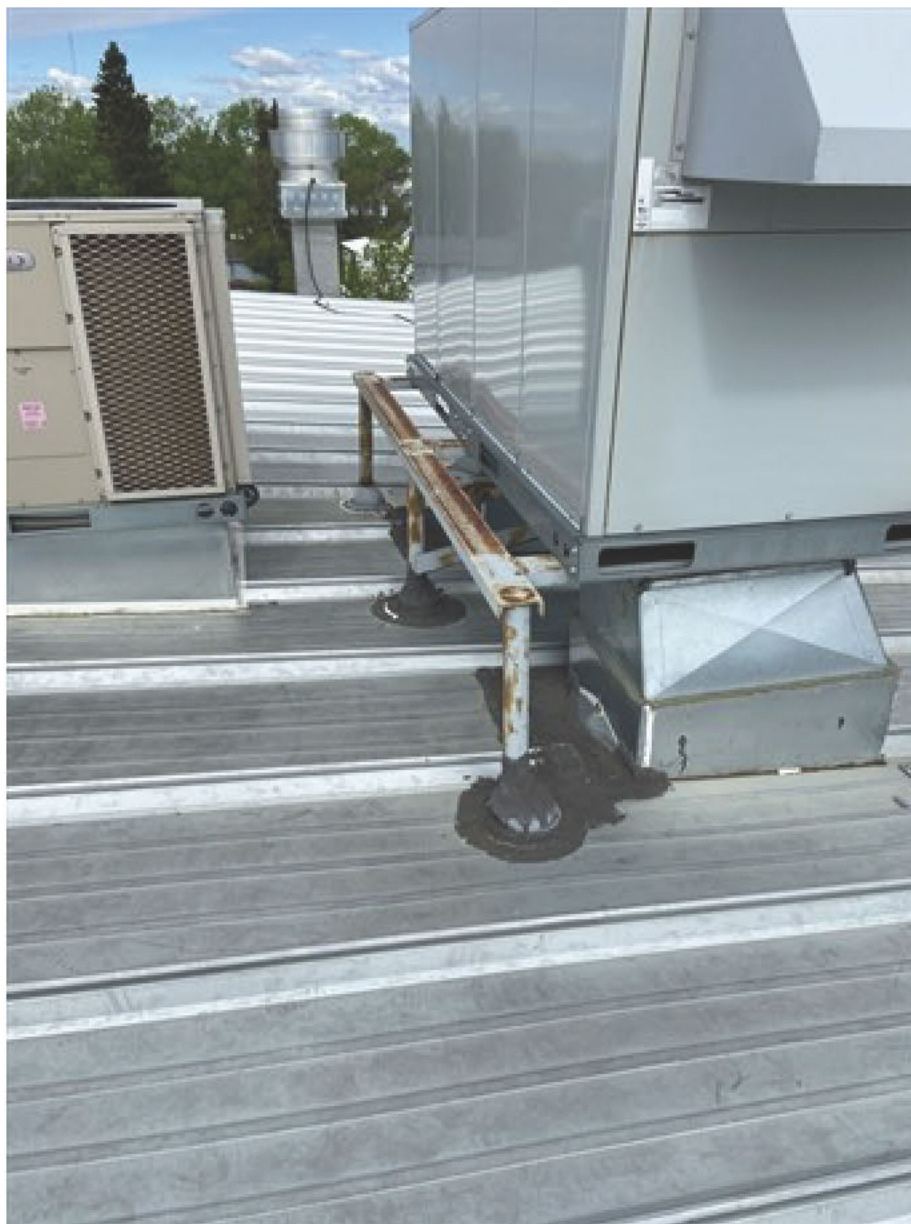
### A.5

General view showing support flashings and roof tie-ins in poor condition. Sealant ageing and deterioration is evident around various curbs and roof penetrations/tie-ins.

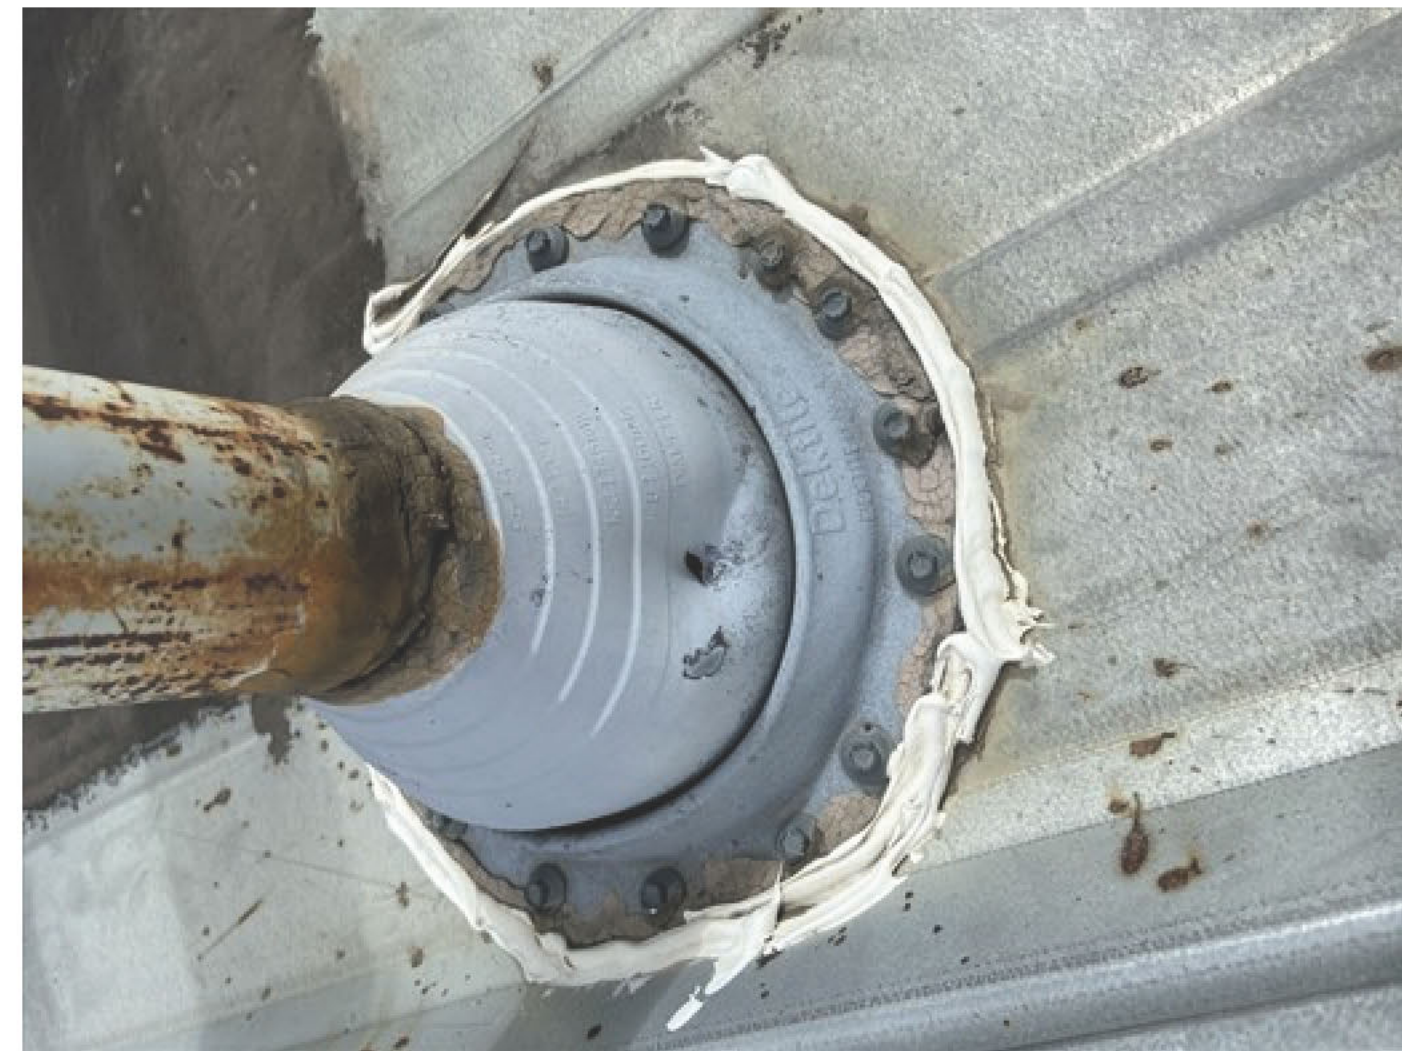
### A.6

Close up view showing sealant cracking and separation around multiple supports.

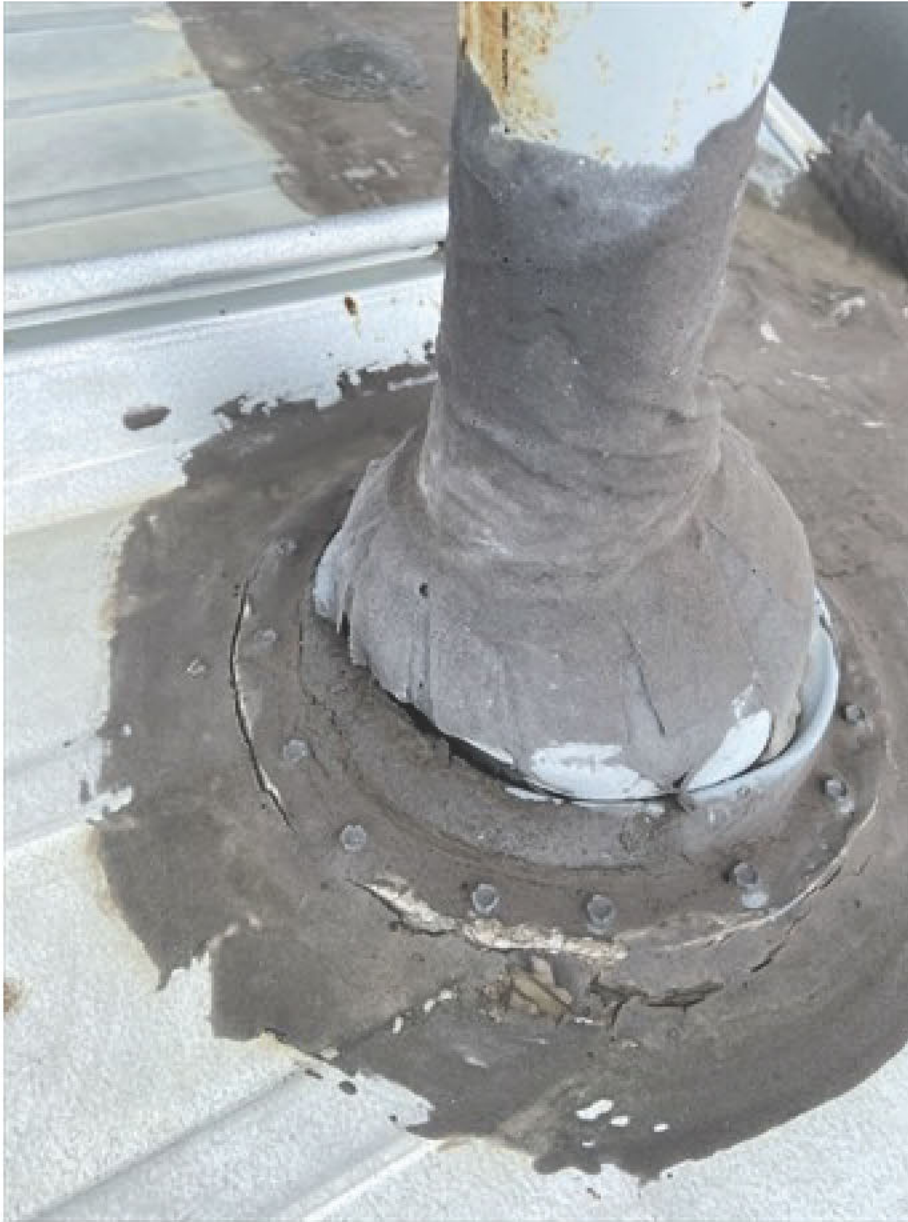
**A.7**

Existing coating separating along the tie-ins due to missing reinforcement.

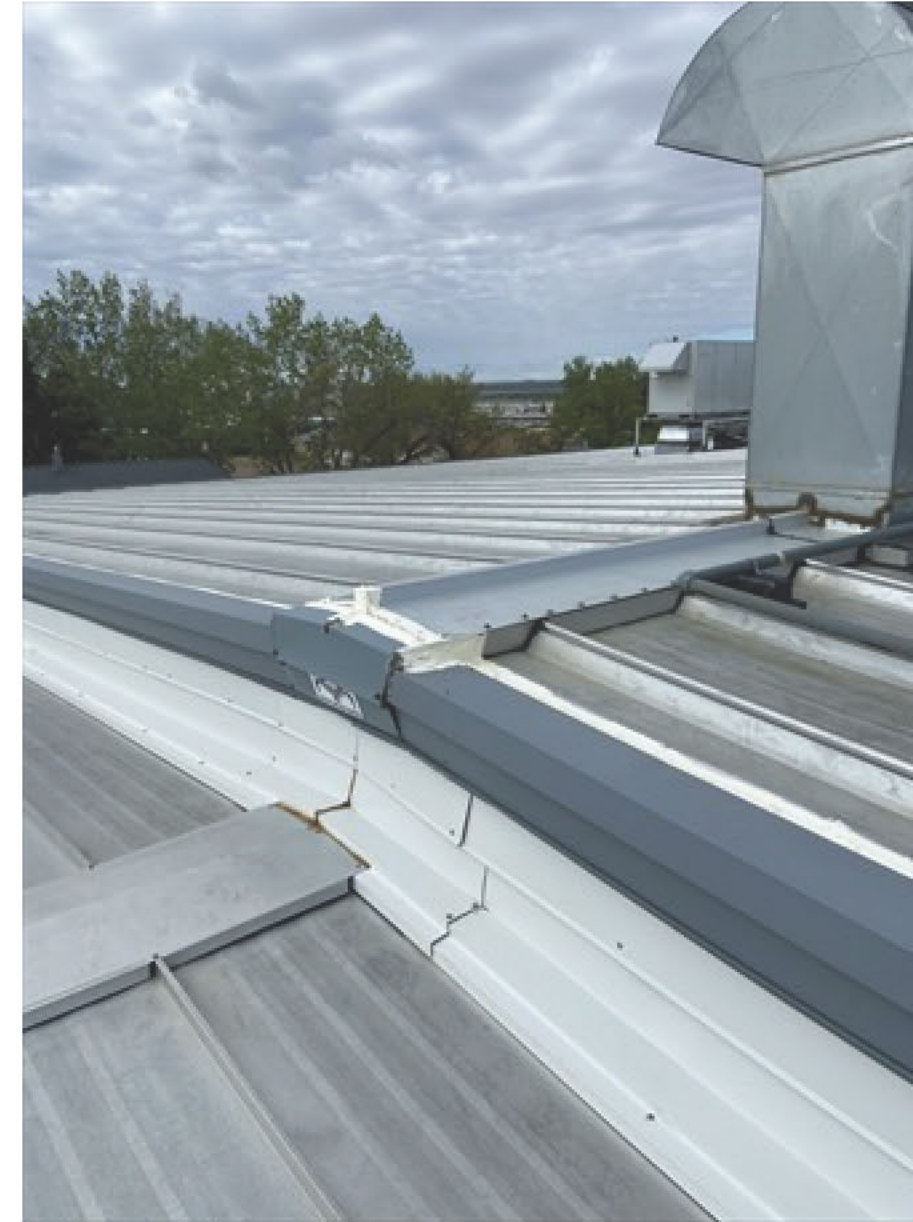
**A.8**

Sealant cracking and deterioration below the ridge cap flashing and on the end caps.

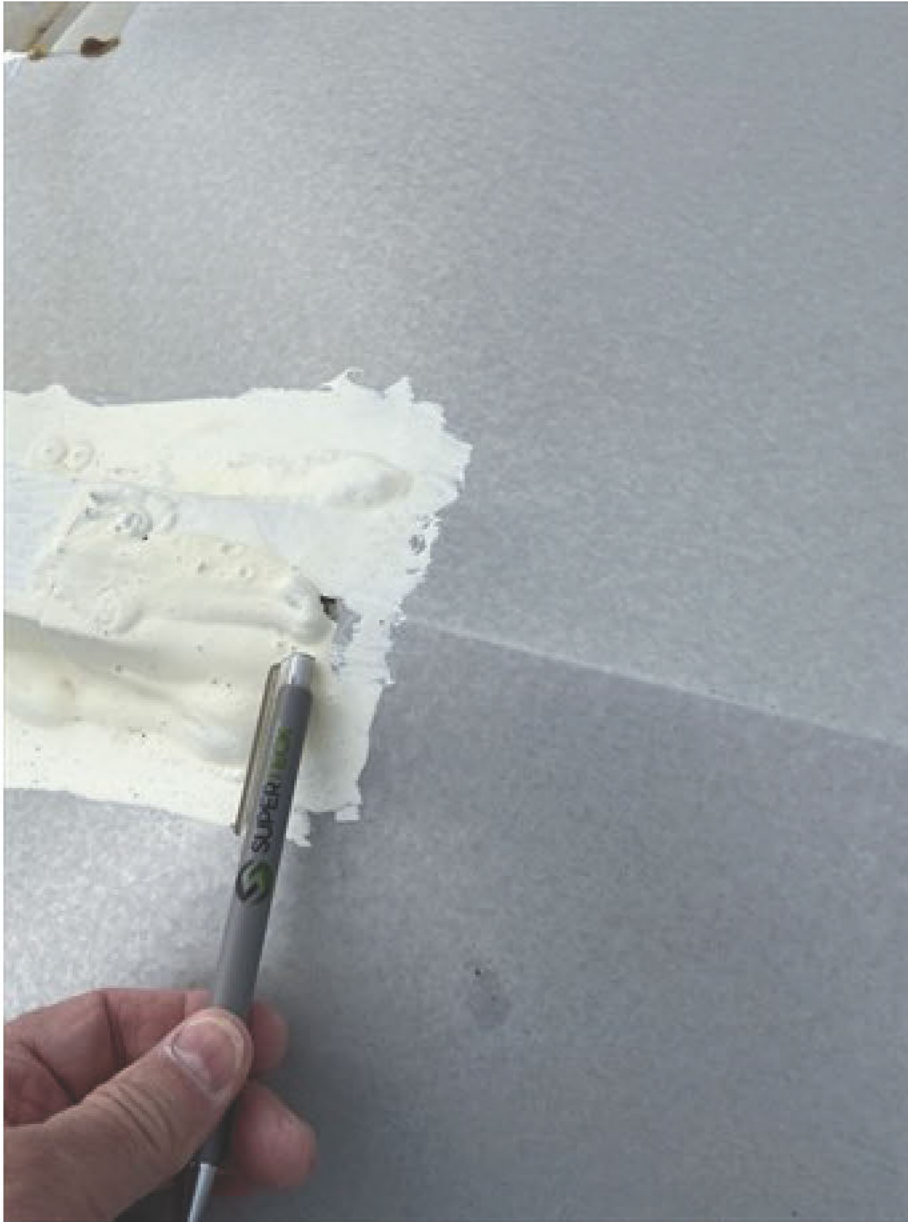
**A.9**

Close up view showing incomplete repairs.

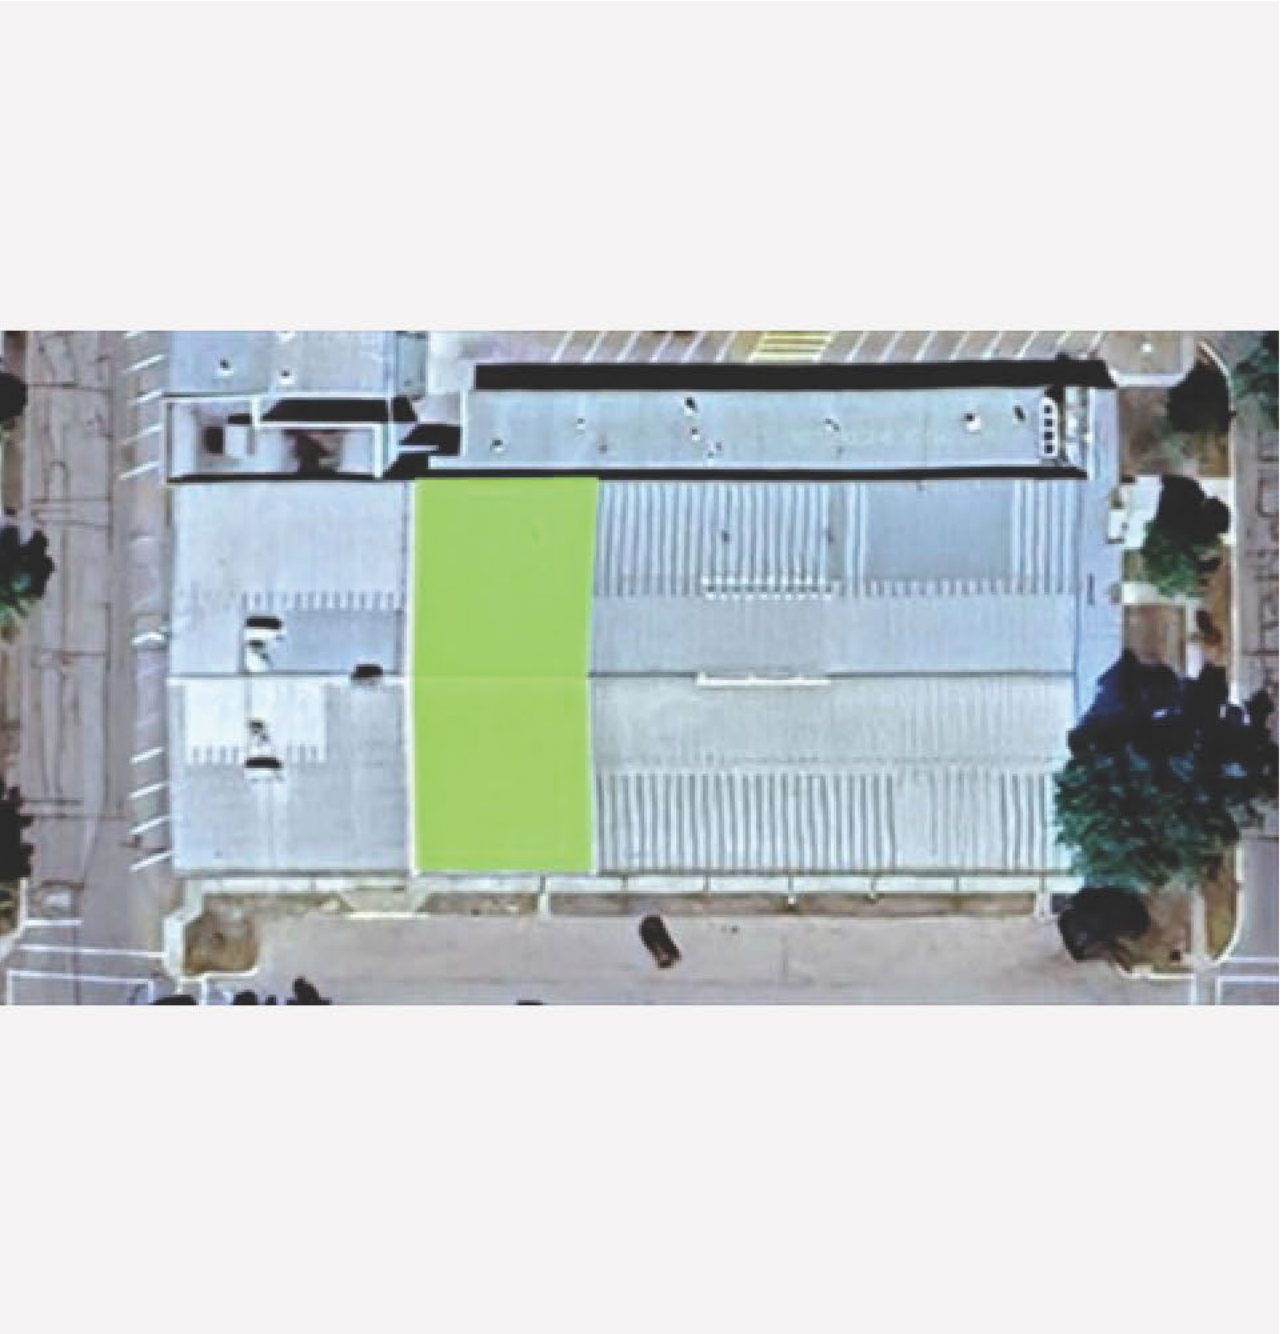
Number of drains	2	Type / système drainage	Gutter
Roofing system	Conventional	Decking / structure	Steel
Insulation panel	Batt insulation	Insulation location	Attic
Membrane composition / Overlay	Metallic	Type de membrane flashing	Liquid, elastomeric finishing membrane
Type of steel flashing	Painted steel, galvanised steel

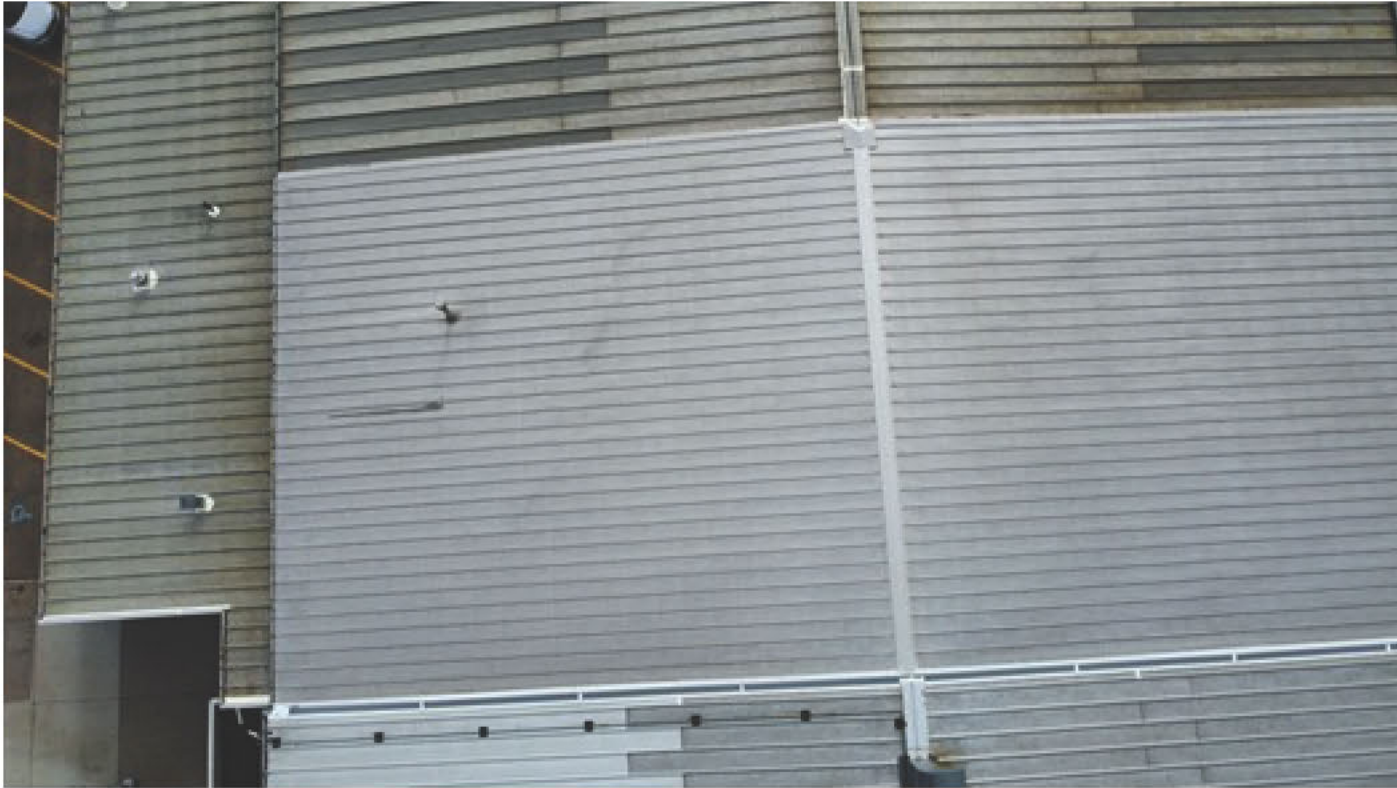
### B1.1

Overview showing roof area B 01 in generally fair condition. Existing panels are well secured in place using proper fasteners.

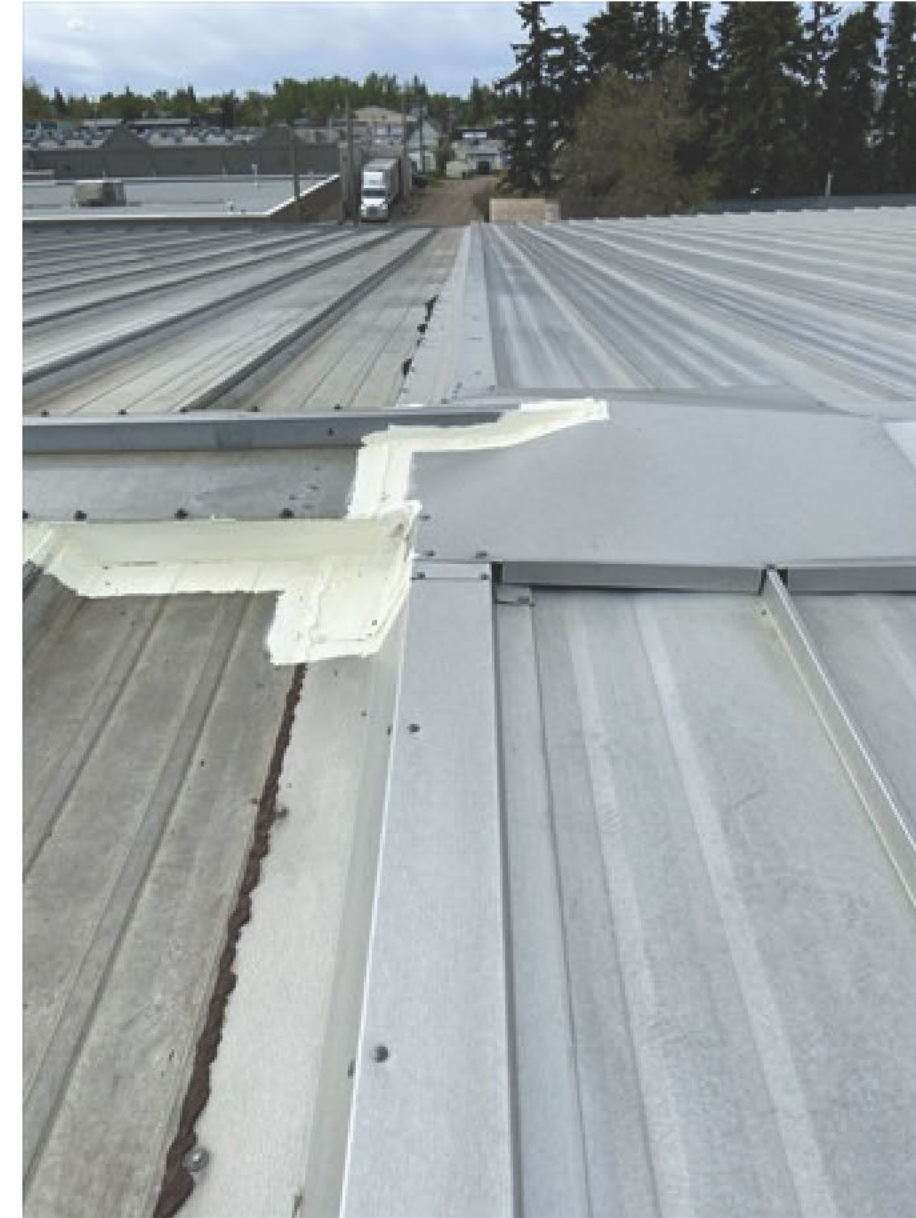
### B1.2

General view showing the existing metal roofing panels in fair overall condition. Sealant failure was observed between the metal flashings and roofing panels along the roof divider, allowing water ingress to occur.

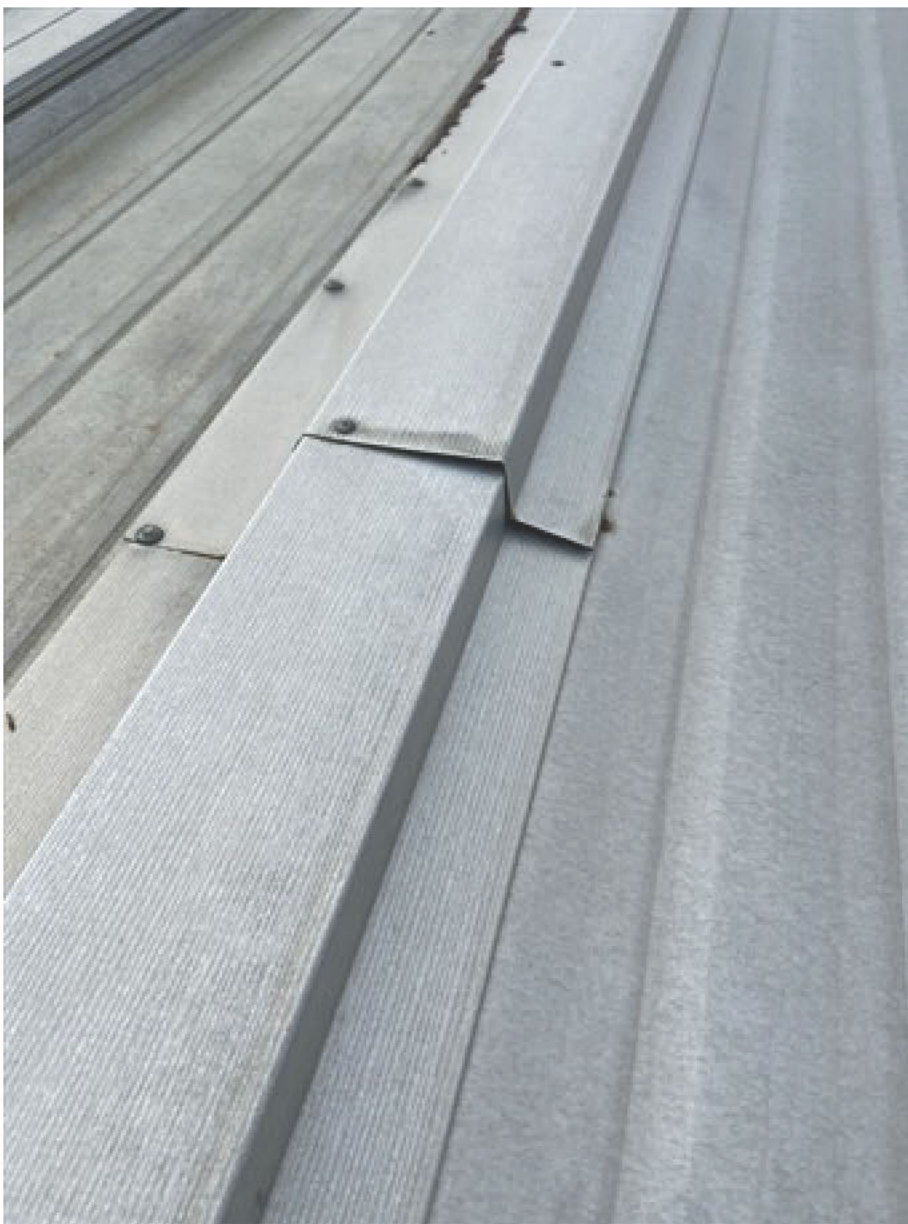
**B1.3**

Close up view showing inequality secured metal flashings and metal punctures along the roof divider.

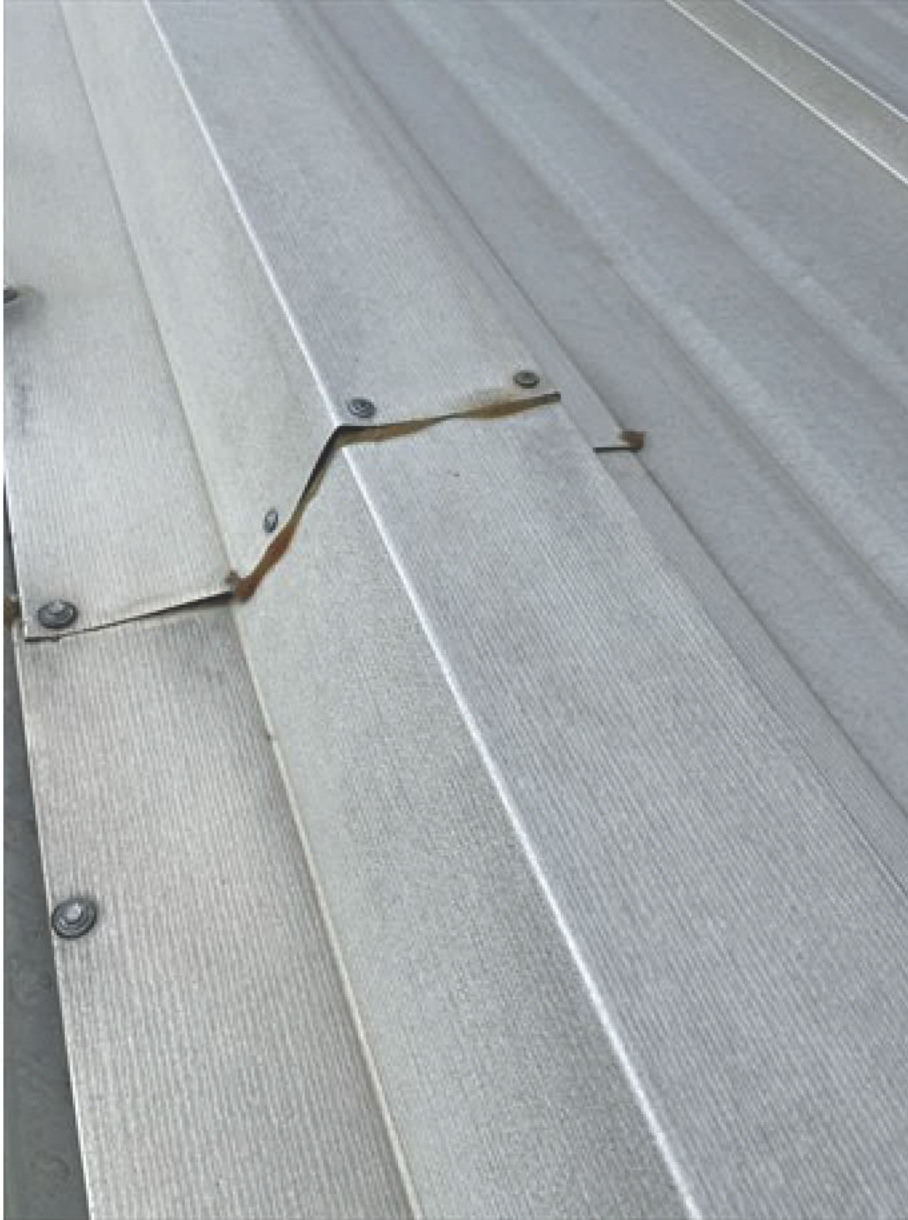
**B1.5**

Close up view showing sealant separation along multiple metal joints and tie-ins.

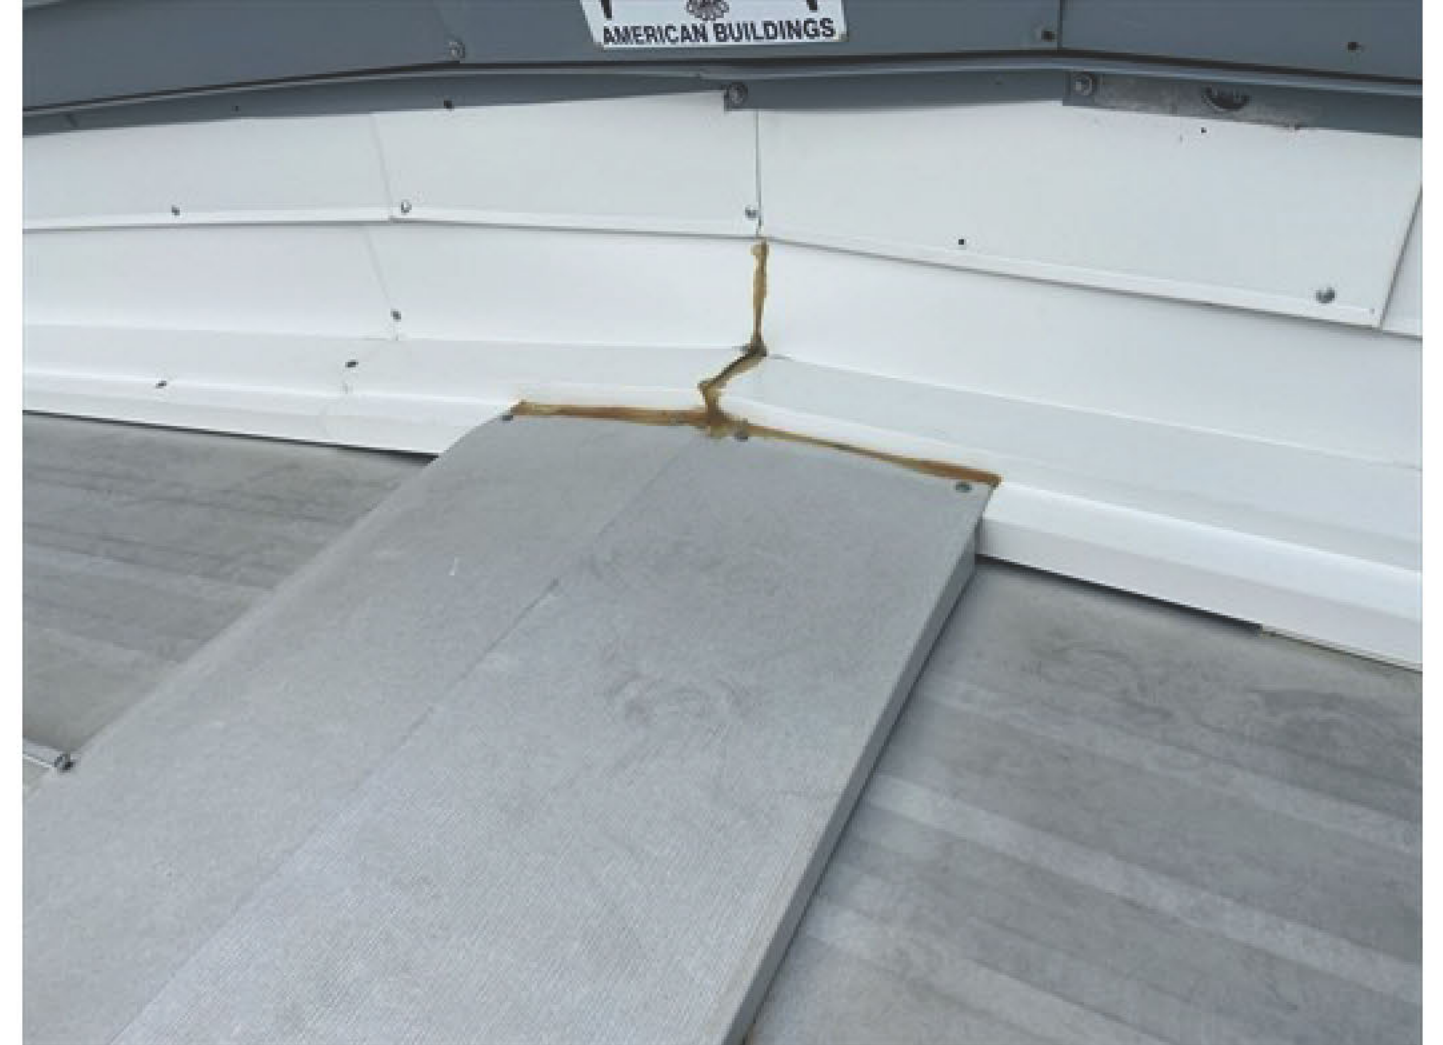
**B1.6**

Sealant ageing and deterioration along the ridge cap flashing.

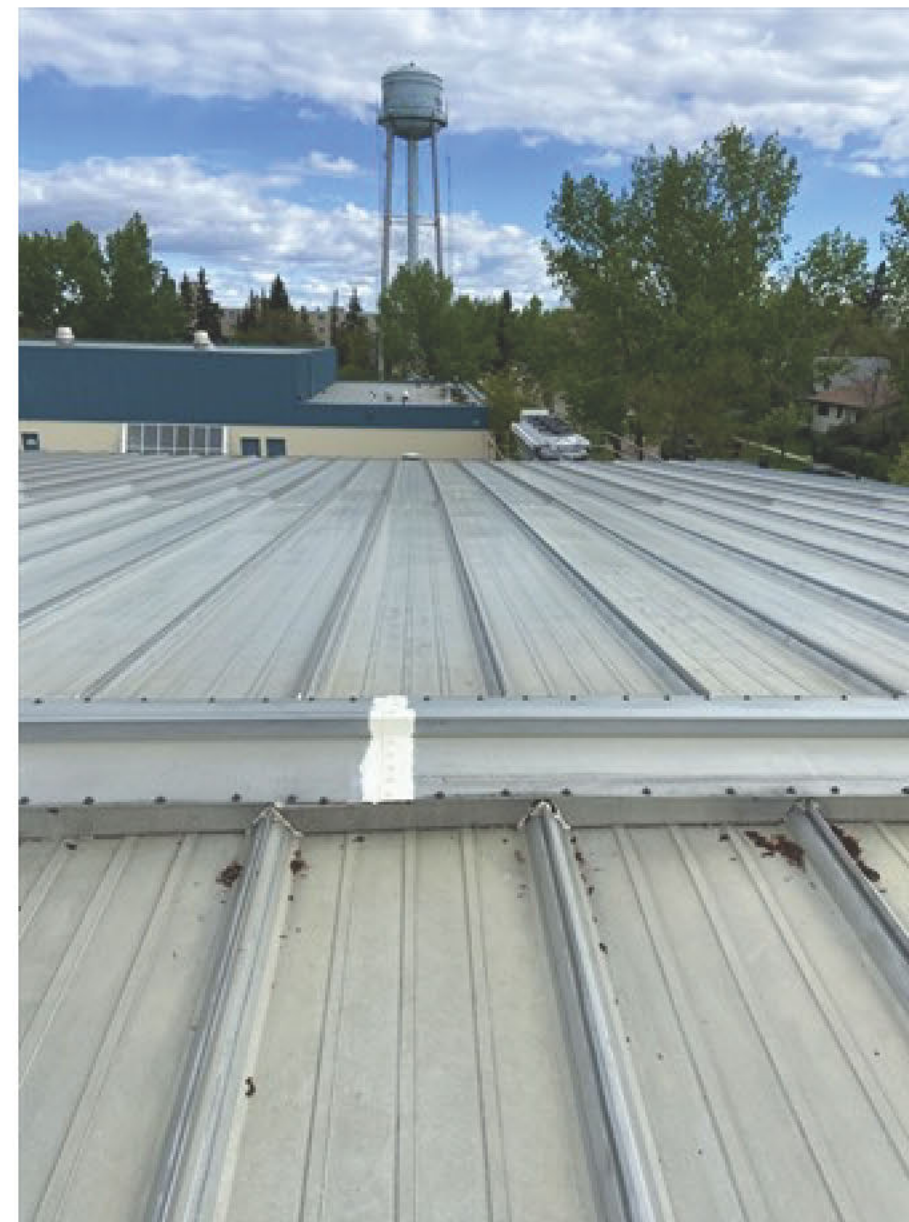
## B2.2

View shows panels in overall fair condition. Sealant ageing and cracking is evident below the ridge cap flashings in multiple areas.

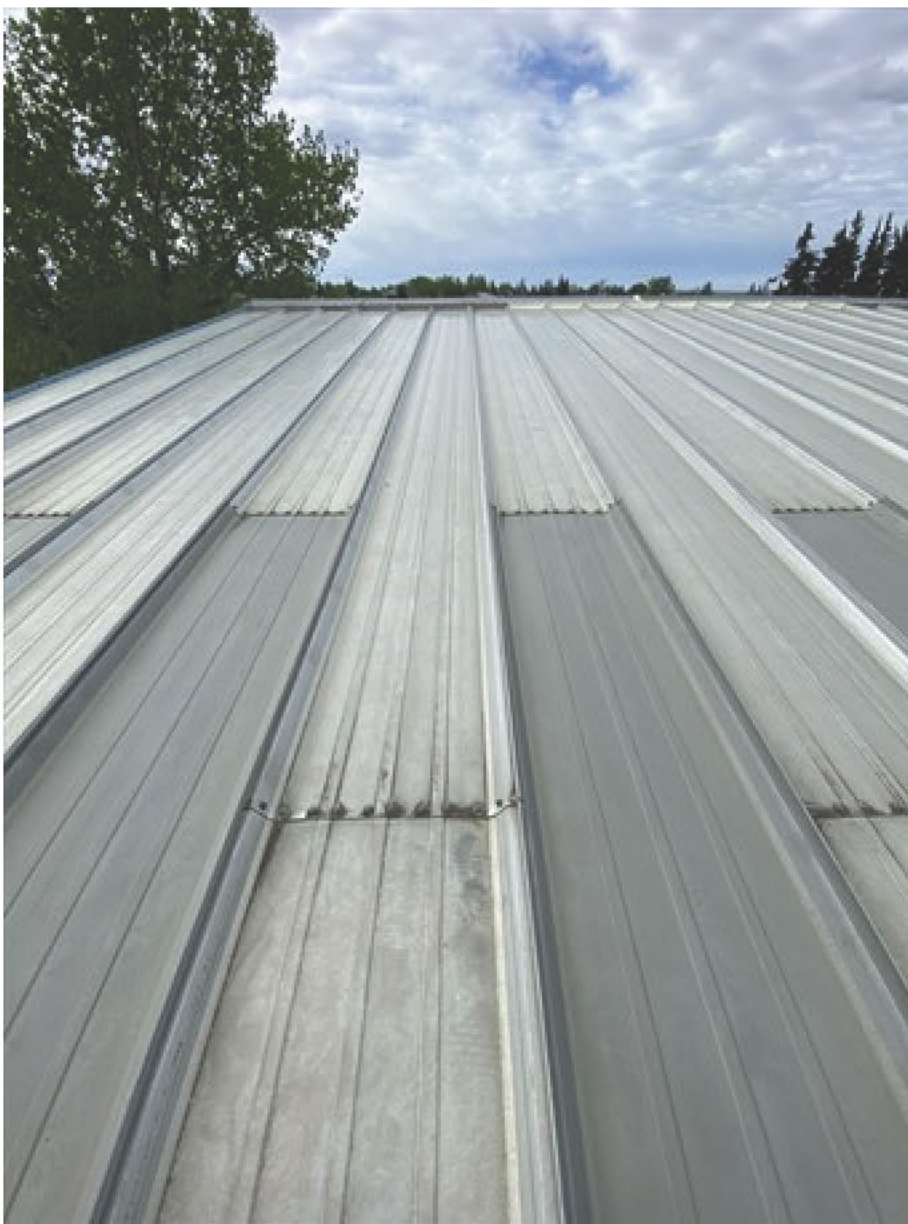
**B2.3**

Sealant ageing and minor signs of deterioration forming around the fasteners on various overlapping seams.

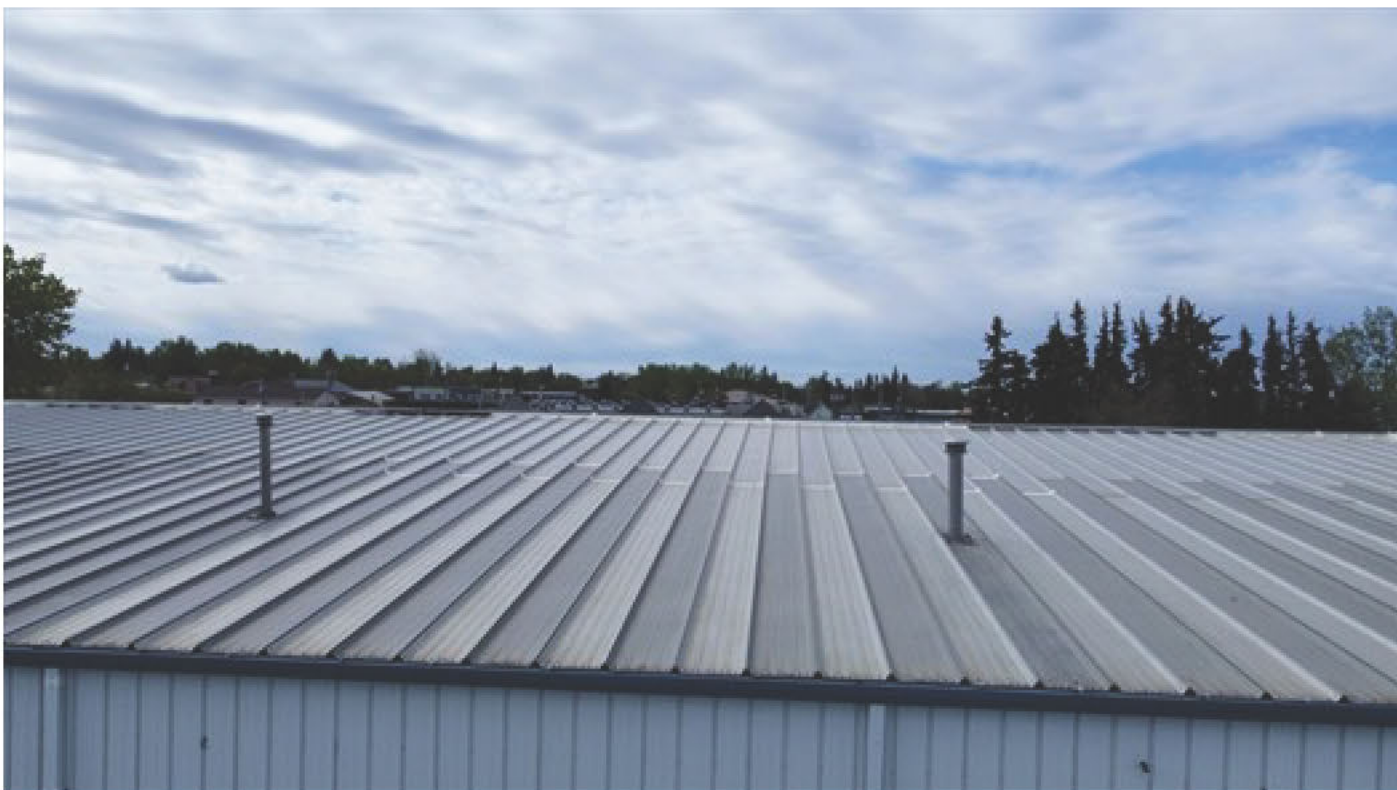
### B2.5

Soil stack pipes at roof level are improperly supported and have fallen approximately 6". This has caused the roof flashing to regress below the metal panels and may allow water infiltration to occur. Sealant separation has also occurred around the pipes and roof tie-ins.

General view showing damaged/inadequately supported soil stack pipes on the main roof area. Roof flashings are damaged and no longer fully sealed, allowing water ingress to occur.
