# TOWN OF THREE HILLS

## REQUEST FOR PROPOSAL FOR Centennial Place Arena – Roof Repairs

# ROOF EXPERTISE REPORT

Name	Address	
Centennial Place Arena	202, 3 Avenue North Three Hills AB T0M 2A0	
Number of roof areas	Number of drains	Total surface
5	15	39,573 pi²
Elevation from ground to roof edge		
General information

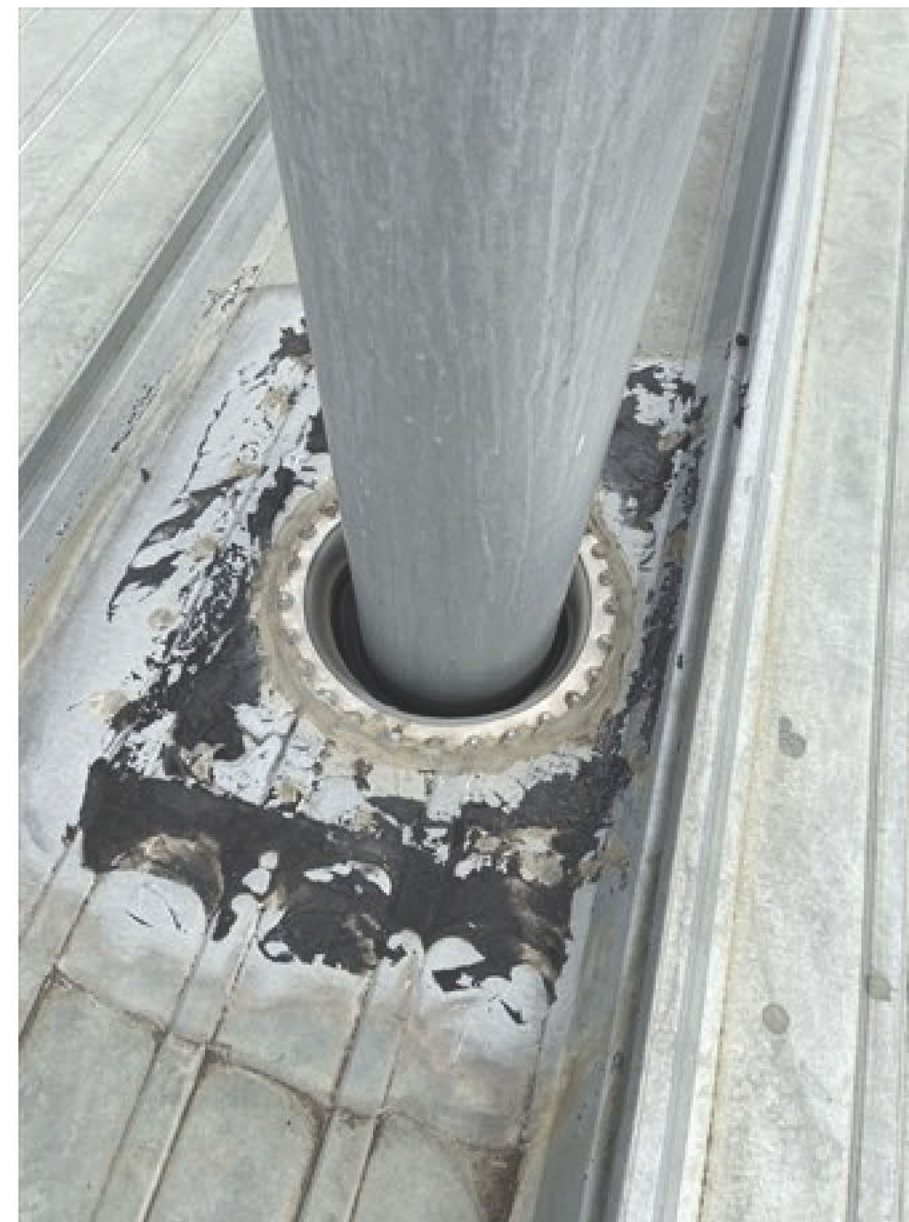
### B2.6

Close up view showing damaged/Improperly supported soil stack pipe causing the pipe flashing to regress at roof level.

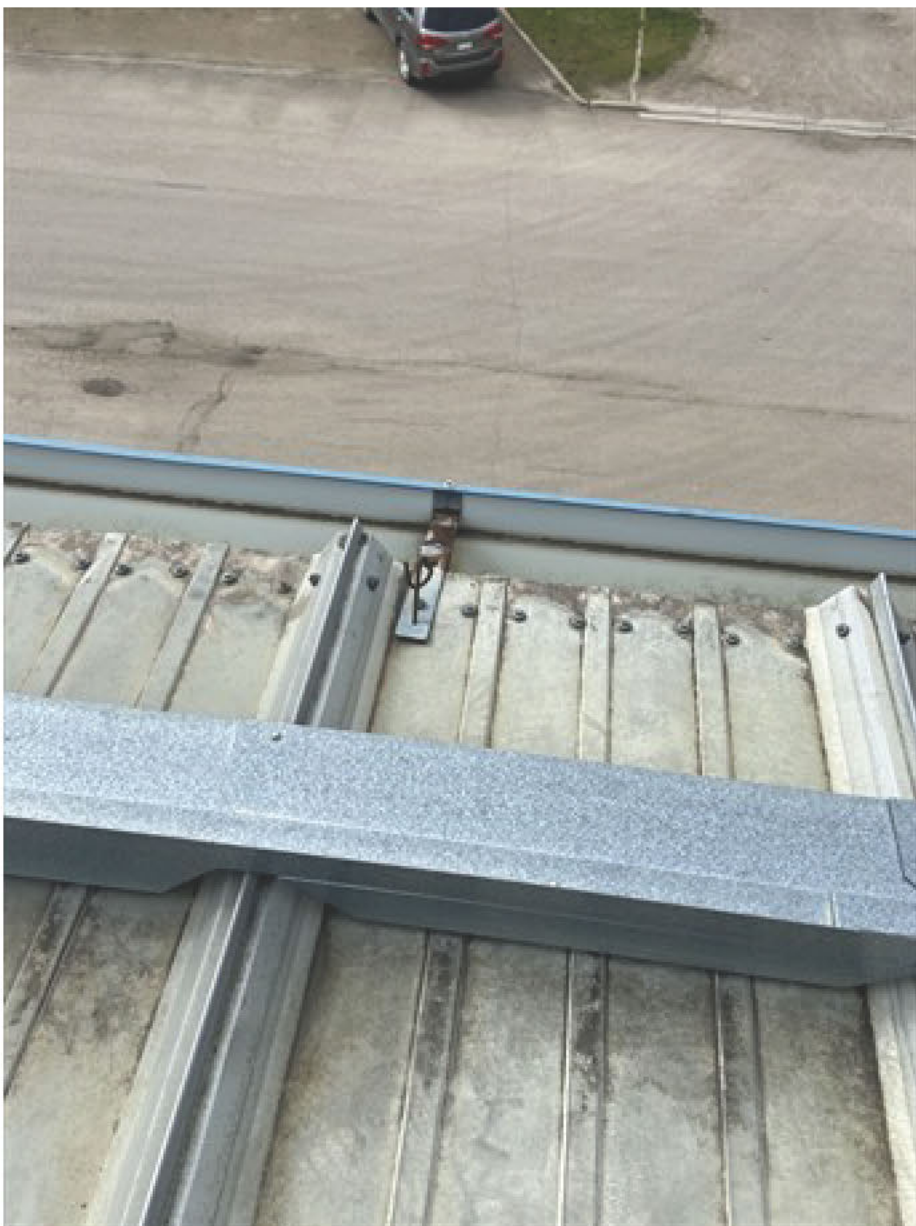
### B2.7

Close up view showing fasteners along the bottom edge in fair to poor condition however remain well secured in place. Minor metal deterioration has begun to form around various fasteners, which may allow water ingress to occur.

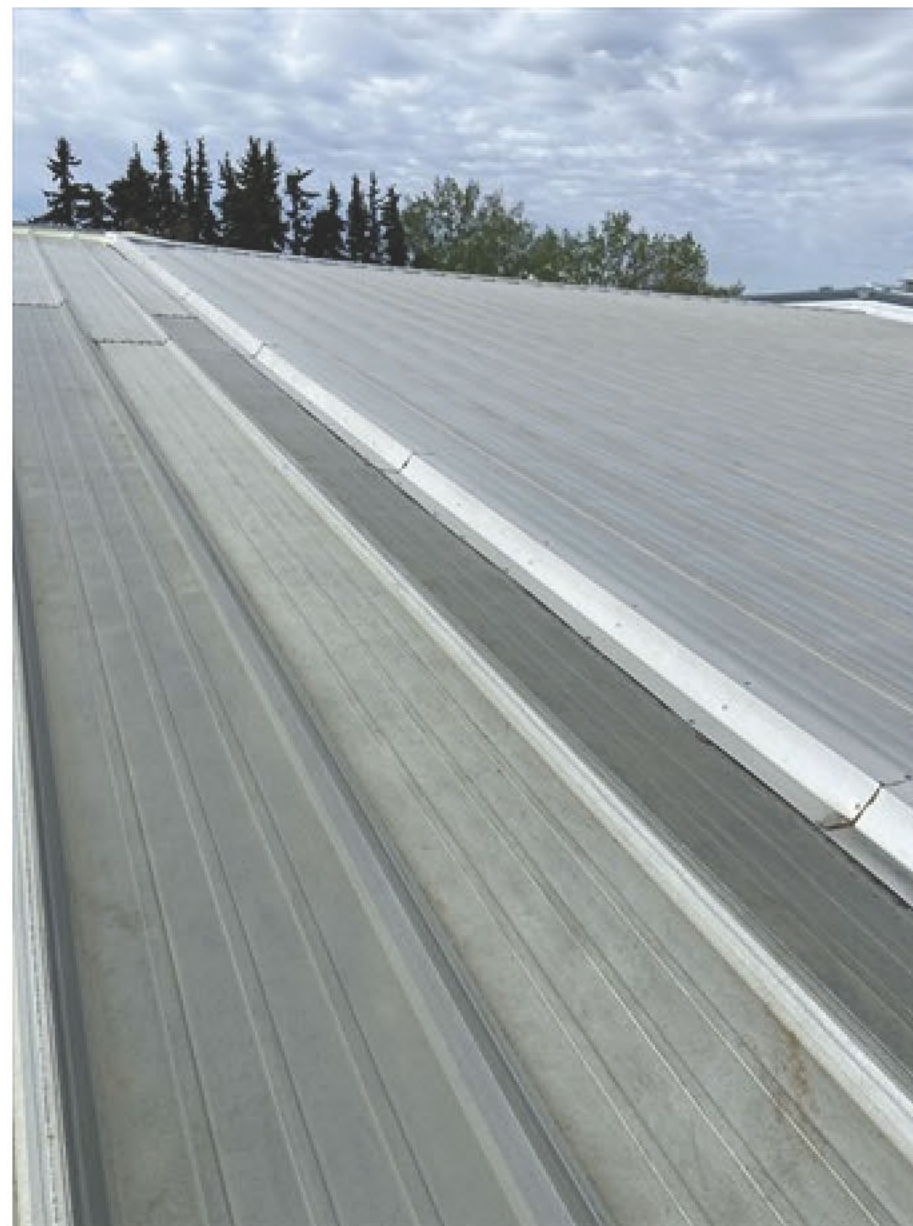
### B2.8

Metal cap flashings along the roof divider well secured in place. Sealant separation and cracking were observed along the metal seams /tie-ins.

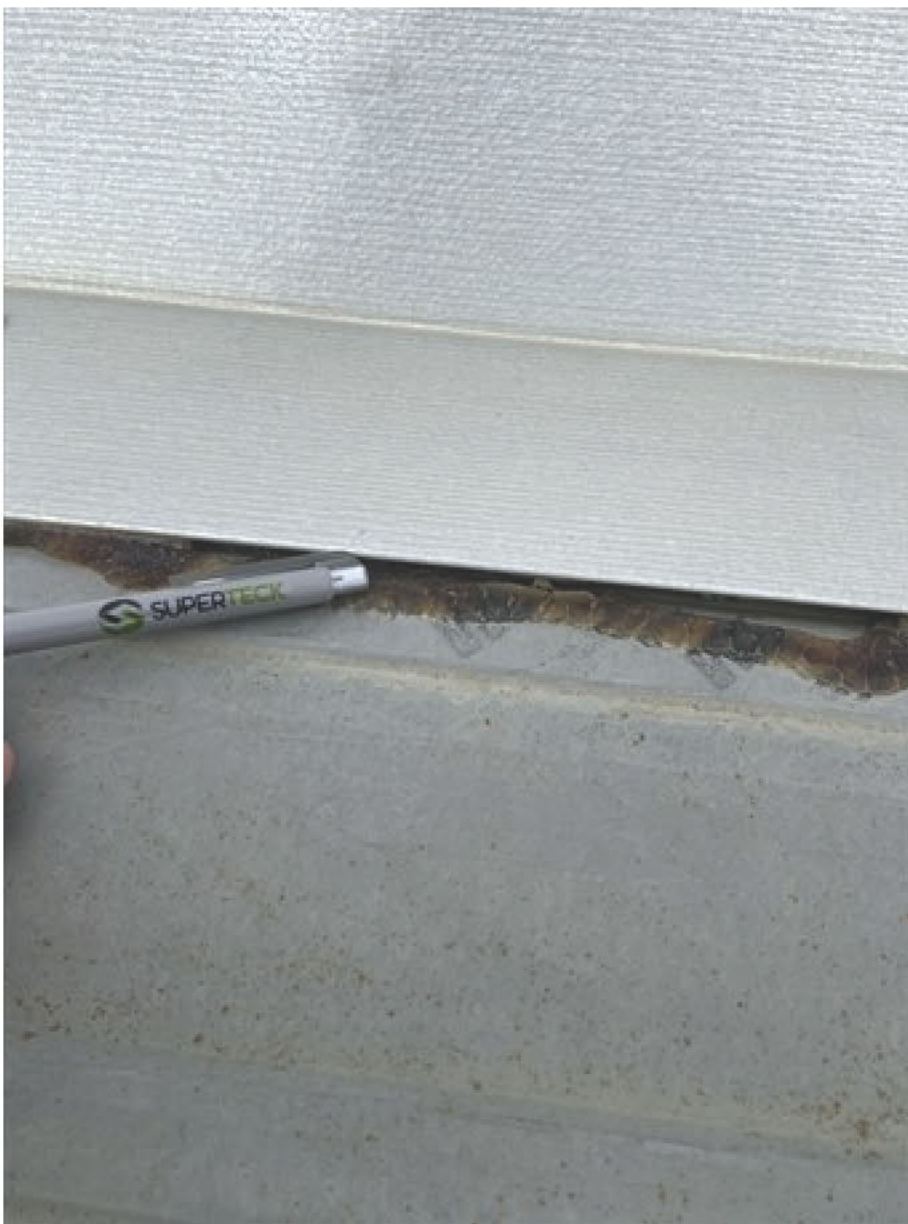
**B2.9**

Close up view showing sealant improperly applied along the tie-in and showing signs of cracking/detreoration.

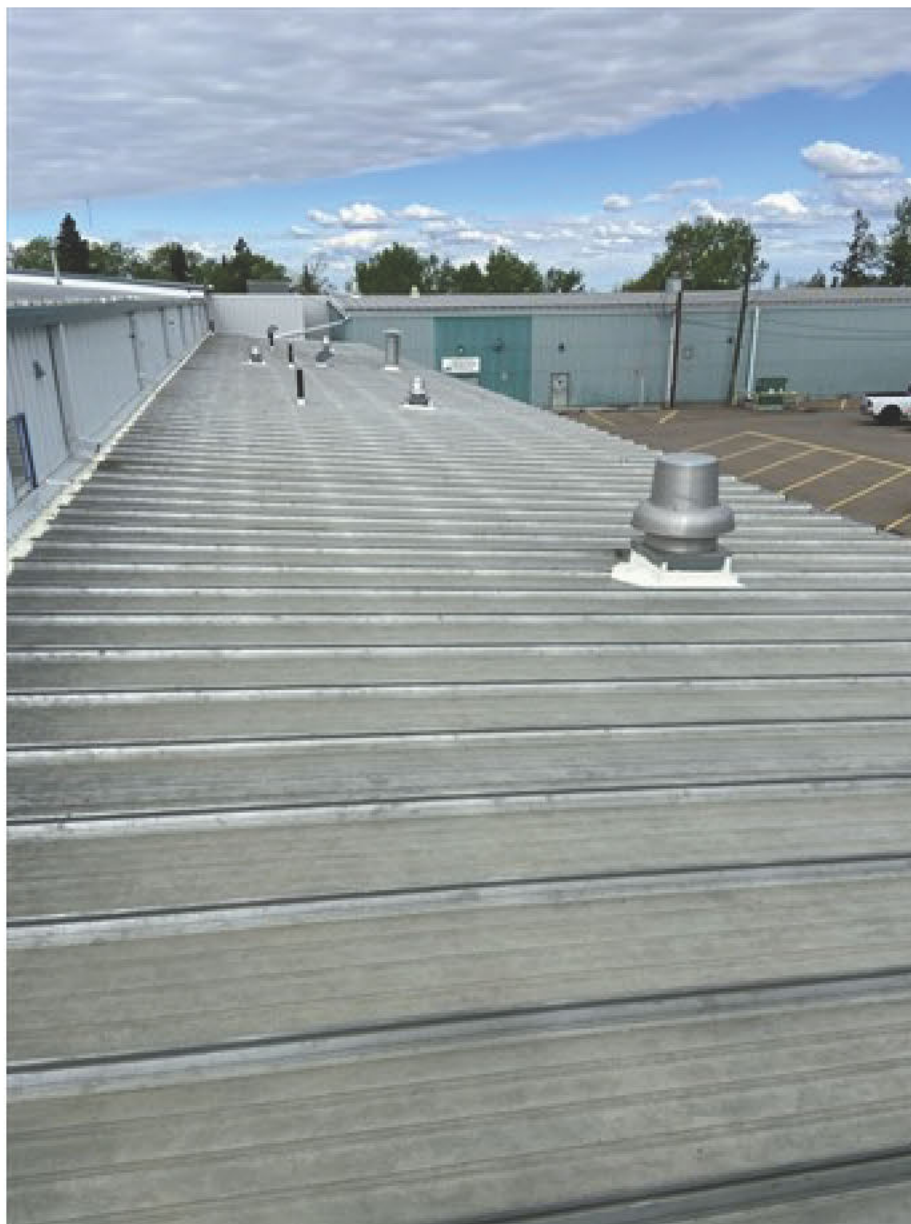
### C.1

Overview showing roof area C in fair to poor condition. reoccurring water ingress occurs along the trough wall flashing detail in the middle of the roof.

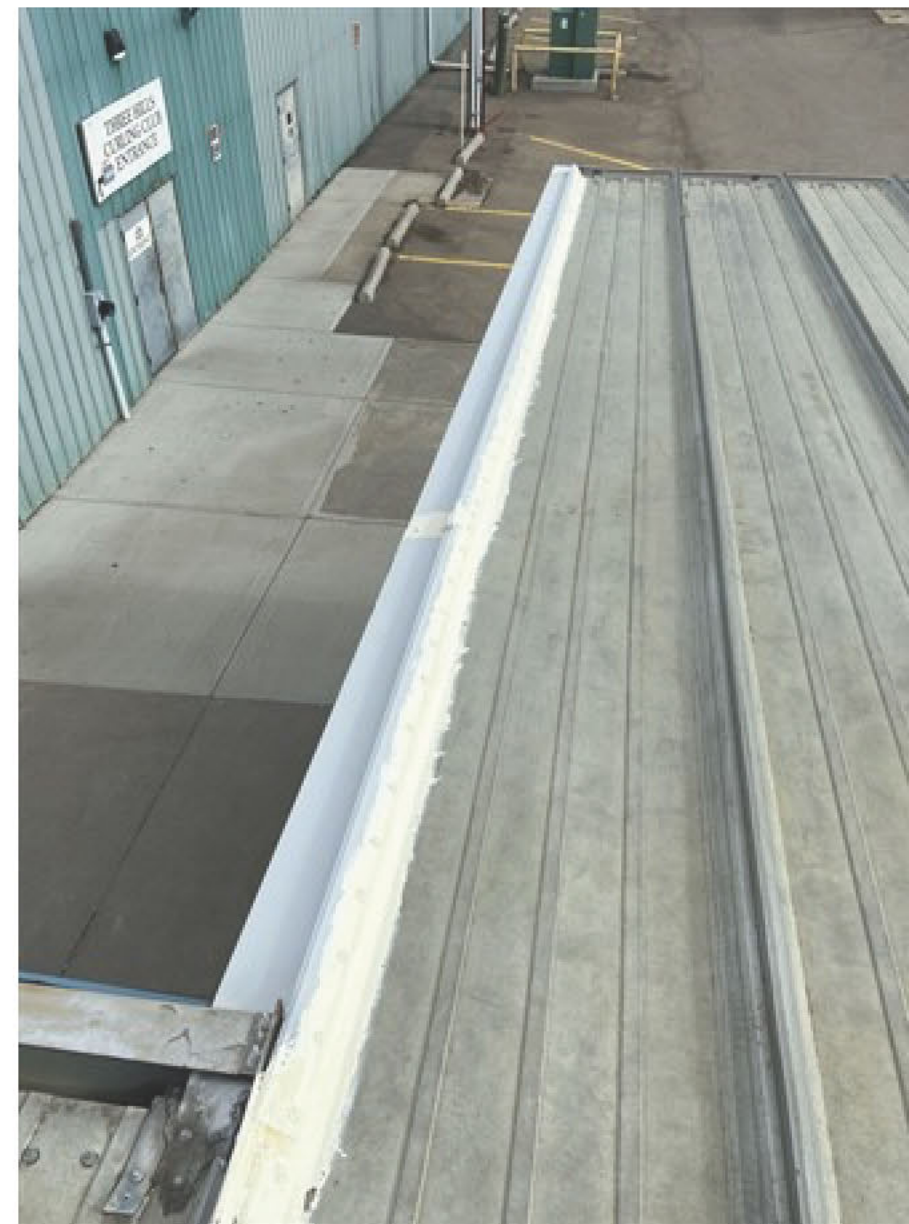
### C.2

Close up view showing the panels in fair to poor condition. Metal perimeter flashings are well secured and have been sealed using elastomeric coating.

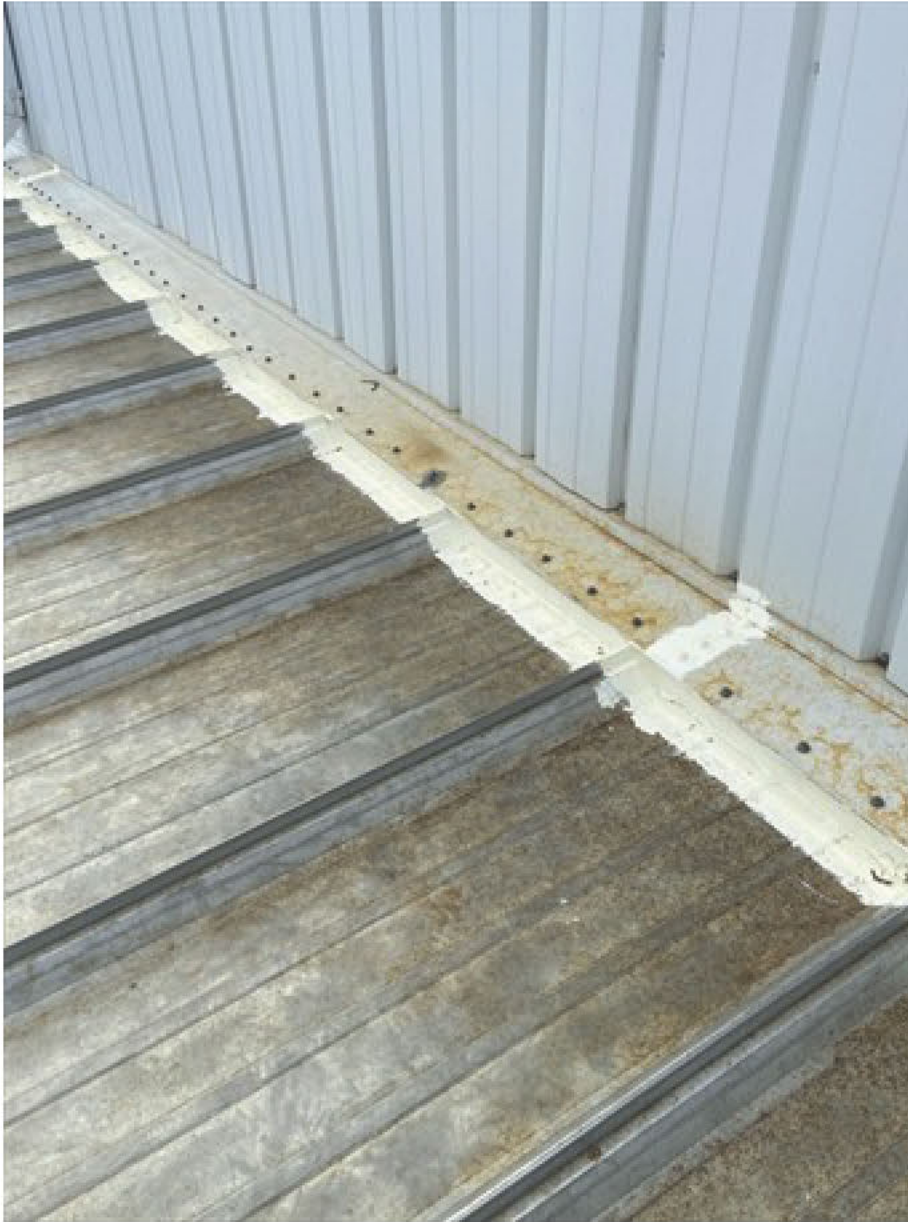
### C.3

Closeup view showing rust and deterioration forming on the panels/flashings along the inside wall. Multiple repairs have been completed along the roof to wall tie-ins to eliminate water ingress. Additional repairs may be required to the through wall

flashings behind the siding.

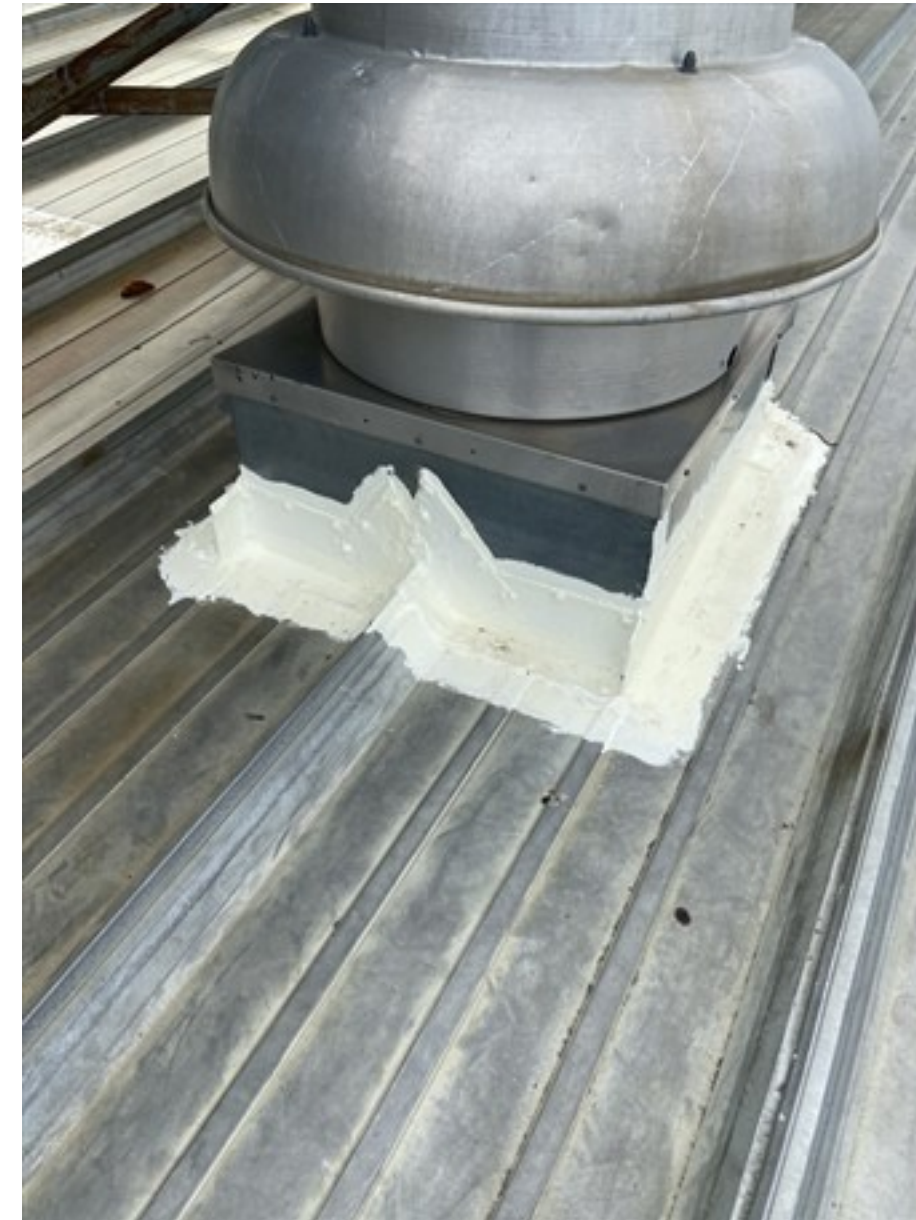
#### C.4

This view shows incomplete repairs around multiple curbs and roof penetrations.

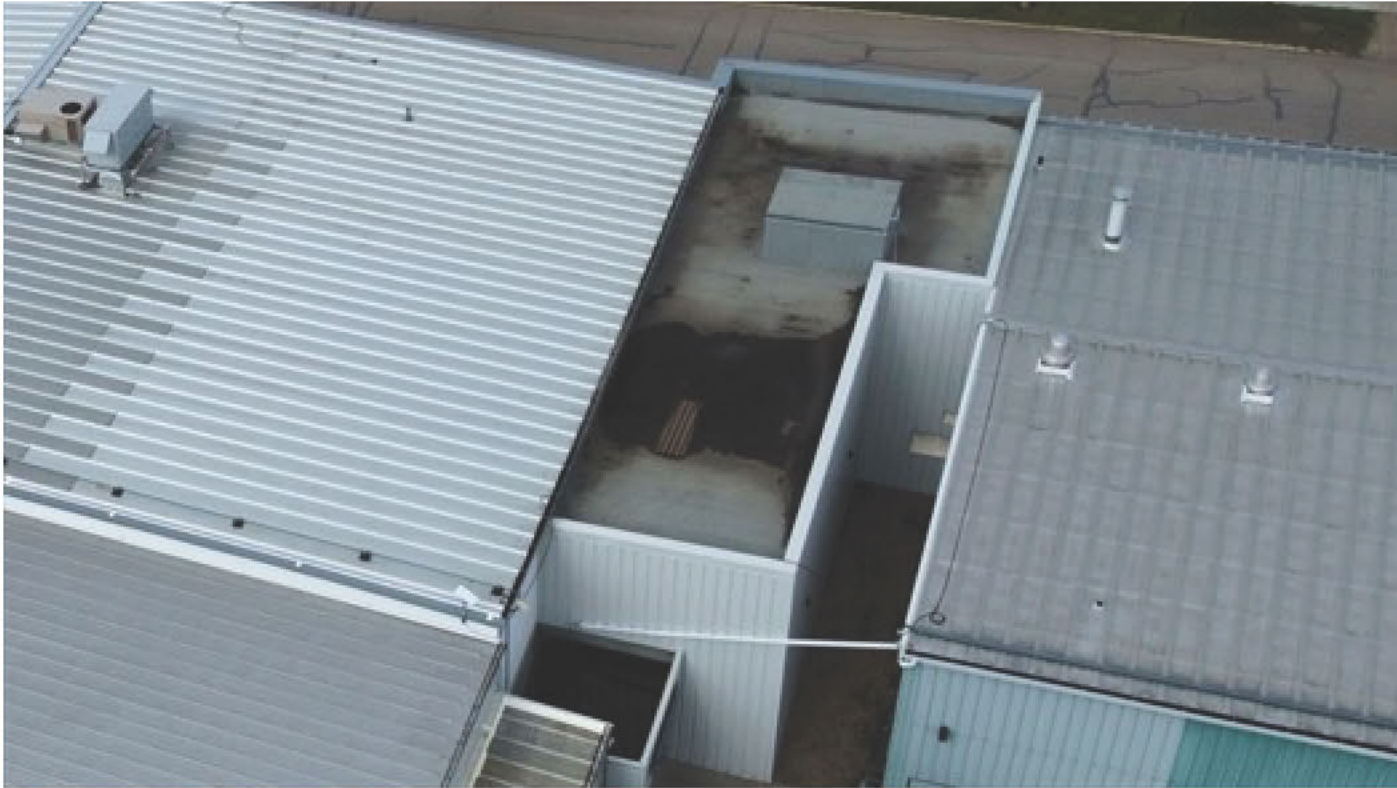
## D.1

Overview showing roof area D in generally fair to poor condition.

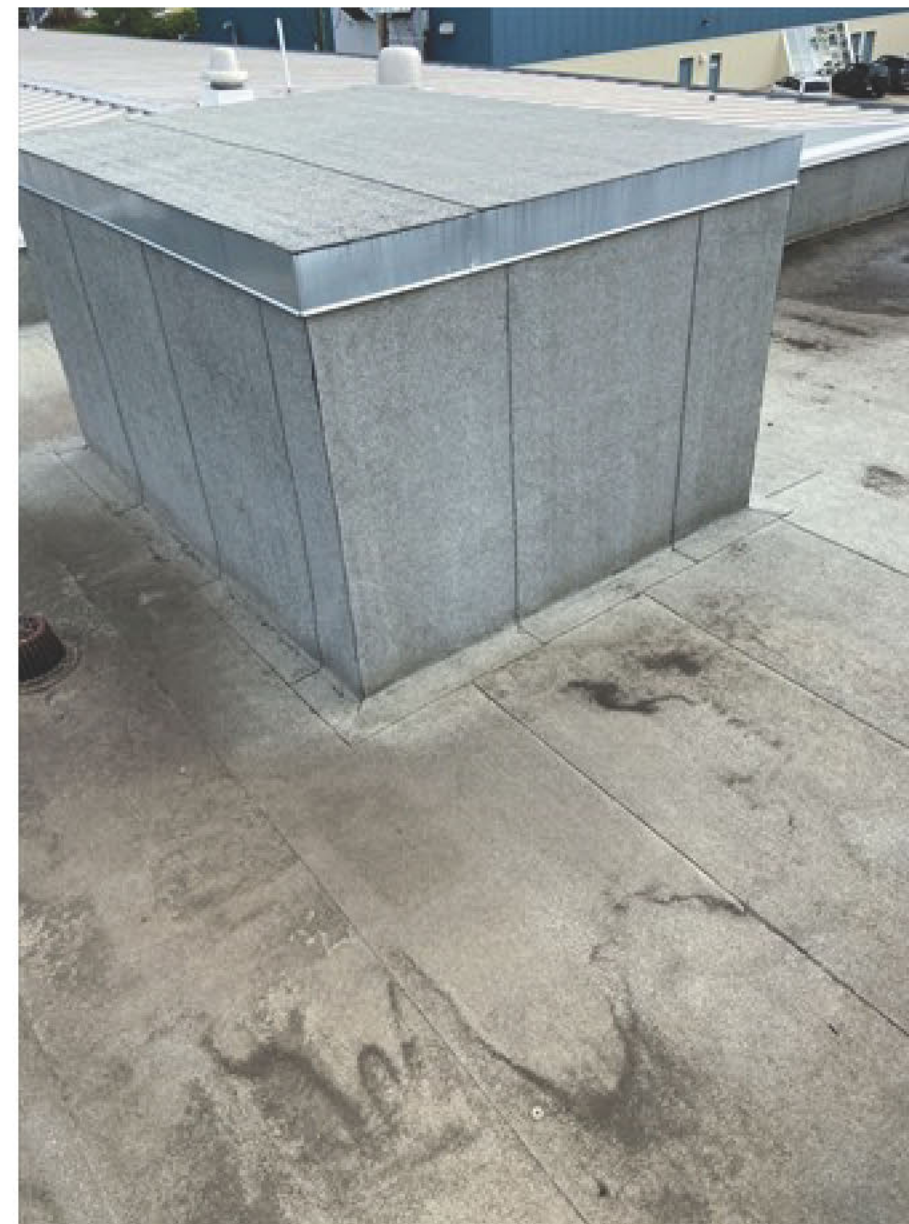
**D.4**

Membrane flashing around the roof curb, sealed and in fair condition.

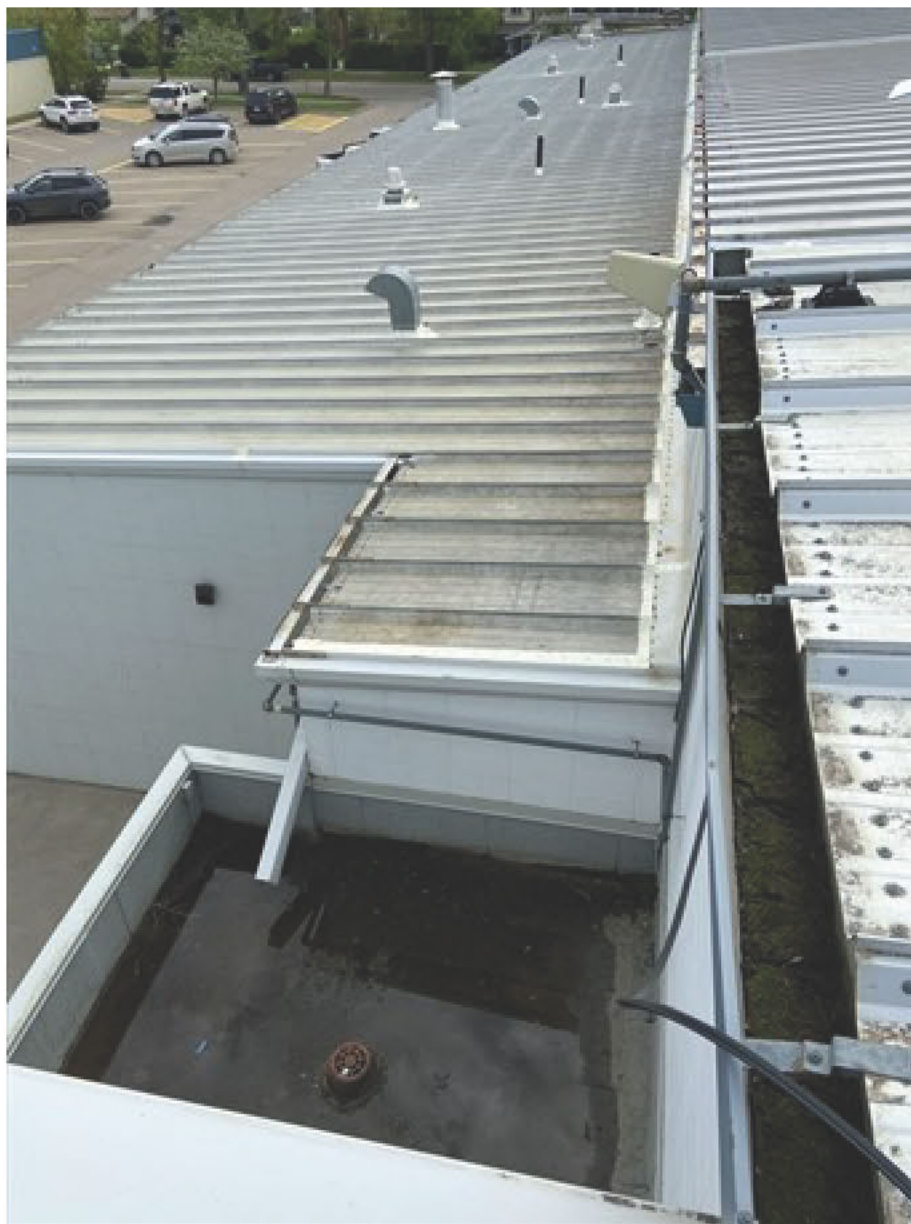
## D.5

General view showing water retention on the lower roof area, due to blocked roof drain.
